CITY OF PACIFIC GROVE

**Sewer Pump Station Condition Assessment
September 2021**

Sewer Pump Station Condition Assessment

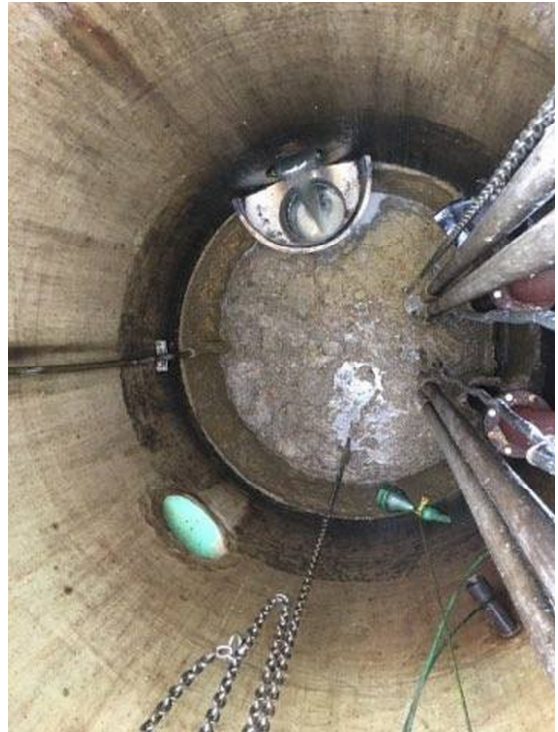
Eardley lift station is a medium size lift station for the City, both in terms of discharge flowrate and physical dimension. In general, this lift station appeared to be in good condition. The valve vault was in very good condition and appeared to be “like new” but some of the components in the wet well showed signs of corrosion. For example, the grating that comprised the secondary fall protection over the wet well and the ductile iron discharge piping showed signs of corrosion. Stainless steel components, like the pump lifting guiderails were in good condition and showed no signs of corrosion. Electrically the lift station was in good condition as well, with the control panel interior appearing “like new.” To assess the quality of the electric motors powering the pumps, the pump motors were megohm tested. The megohm test determines the degree to which the electric motor windings are insulated. A new motor should demonstrate infinite resistance (infinite megohms) and as the motor is used, resistance decreases. The closer to zero resistance, the closer the motor is to failing. Please note that it is not predictable exactly how much life a pump may have left regardless of the megohm reading, but this is the best indicator of pump life expectancy.

Figure 2. Eardley lift station significant grease mat.

Grease and grit accumulation- 100% grease mat on the surface of the station, very thick and odorous

- Install “seal-offs” on all conduits that penetrate control panel
- Mitigate grease load into lift station – grease trap upstream
- Treat grease in lift station – wet well enzyme additives to enhance breakdown of grease
- Evaluate the number of starts/stops for this lift station. If the number of start/stops is minimal, it is recommended to reduce the difference between pump-on level and pump-off level to increase the start/stops per hour, without exceeding manufacturer recommended start/stops per hour
- Coat secondary fall protection and discharge piping
- Maintain records of impeller and volute wear

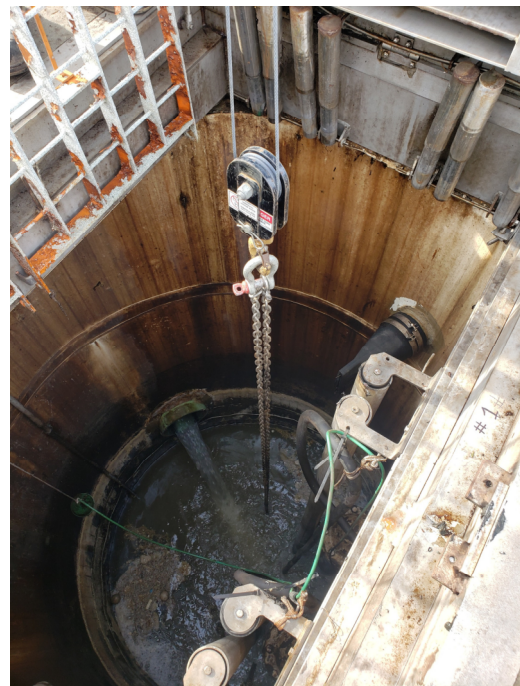
#12 lift station is the largest of the City’s lift stations and appeared in good condition. The wet well has a coating that is in satisfactory condition, but the secondary fall protection demonstrated heavy corrosion. While the check valves, isolation valves, and bypass piping were in good condition the ductile iron piping in the wet well was corroded and the coating on the piping has failed. The guide rails (stainless-steel) and access hatches were in good condition. The pump motors were not able to be megohm tested as a result of panel arrangement, so no assessment of pump motor condition is provided. Both pumps did produce approximately 850 gpm each which appears to be near maximum efficiency based on manufacturer’s data. The control panel did have seal-offs installed and the electrical components inside the panel appeared in good condition. Epoxy was used to fill all splices into the control panel which adds water resistance and keeps the splices in good condition. The below grade structure that houses the electrical system and back-up generator was in good condition. A large grease mat was noted even though operations staff installed grease blocks. There were no structural concerns for this lift station.

Figure 3. #12 lift station with visible corrosion on fall protection grating.

Corrosion- Secondary fall protection showing heavy corrosion

- Re-coat secondary fall protection and replace corroded components as necessary

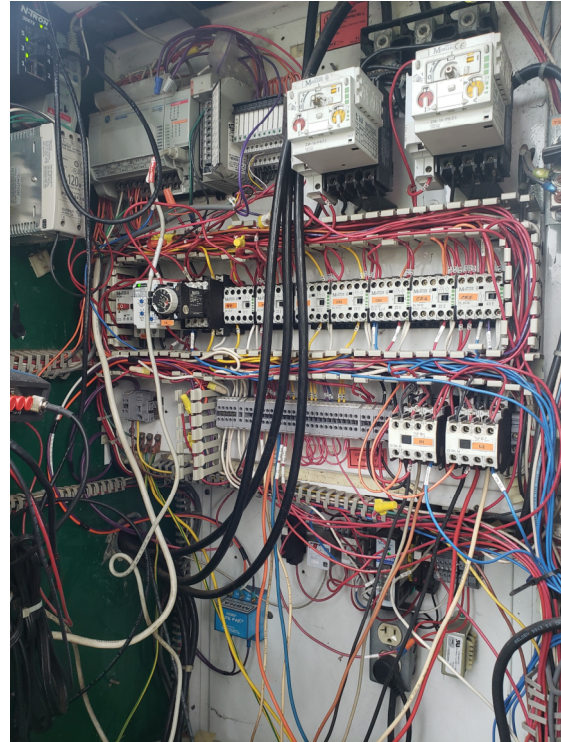
Lover’s Point lift station is a smaller lift station. Mechanically the lift station was in serviceable condition, but it also demonstrated electrical and corrosion issues. Pump 1 produced 144 gpm while pump 2 produced 112 gpm. However both pumps demonstrated only moderate megohm readings. The three leads on pump 1 averaged 570 megohms and pump 2 averaged 355 megohms. The lower megohm readings are indicative of failing motor winding insulation or poor splice condition. Because the splices were in satisfactory condition it is more likely the pump motors are beginning to wear out. According to the manufacturer’s pump curve, the pumps are operating far from the point of best efficiency and a couple more feet of head on the pumps would lead to greatly reduced discharge flowrate.

Figure 4. Disorganized Lover's Point control panel wiring.

Notes- Electrical panel has messy wiring, likely from years of service. Overflow line leaving lift station runs to the side of cliff sitting above a beach, line has been capped. Lid to lift station appears to be lower than a storm drain inlet- both are mounted in a depression in the surrounding area.

- Replace discharge piping
- Replace valving
- Obtain schematics and labels, and re-wire control panel
- Replace pumps with pump having operating point closer to best efficiency point
- Maintain records of impeller and volute wear
- Cap overflow pipe in wet well.

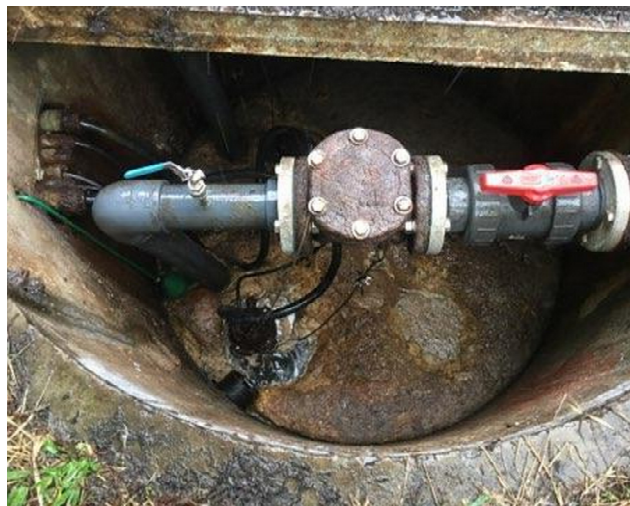
Figure 5. Total mat coverage in shallow wet well lift station #15.5.

surface in the wet well. Material composition of the mat was not only grease but also rags and solids. The sole source of wastewater for this lift station is the adjacent public restroom. The restroom is outfitted with low flow toilets and faucets as well as no flush urinals. The low demand and the low water to waste ratio at this facility partially explains the heavy matting and solids build up. There were no structural concerns for this lift station.

Grease and grit accumulation- 100% grease met on the surface of the station, very thick and full of rags

- Replace lift station with new and/or
- Install a septic tank up stream of lift station or
- Eliminate lift station and install gravity sewer from restroom to trunk line beneath Sunset Dr (this would need to be verified to determine if feasible)

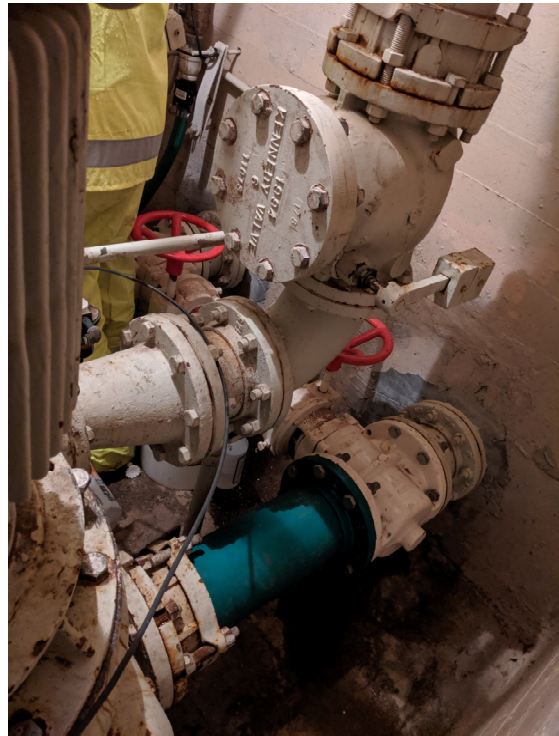
The Arena lift station is in good condition. The dry well type lift station has a two tier dry well. On the upper tier are the electrical systems. The control panel wiring and components were in good condition and the 60kW natural gas generator proved to be operational. Similarly, the soft start contactors were proved to be in satisfactory condition after being disassembled for inspection. On the lower tier of the dry well structure were the mechanical components of the lift station including the two sewage pumps, a dry well sump pump, and ventilation fan. All mechanical equipment was in good operational condition. Pump 1 produced 269 gpm while pump 2 produced 314 gpm. At the time of flow testing a significant amount of flow was coming into the wet well and as such the reported flowrates are anticipated to be much lower than the pumps actual flowrates. Both pumps did demonstrate moderately low megohm readings, indicating the pump motor winding insulation is failing. Suction and discharge piping in the dry well are coated and the coating is in good condition. Check valves, manufactured in 1994, appeared to be operating properly. FRM reported that the pumps would need to be removed in order to verify valve operation. The wet well was also in satisfactory condition with the coating reported to be in good shape. Minimal matting and minor debris were observed to be floating in the wet well. Lift station exterior was in satisfactory condition with some loss of concrete on the dry well lid. Operations staff did point out some areas where vandalism had taken place. The vandals were able to cause minor damage by penetrating the steel mesh covering some of the dry well openings, including a motorized louver vent.

Figure 6. Red-handled isolation valving in the Arena lift station.

- Confirm operation of isolation valves
- Inspect impeller and volute wear on both pumps
- More robust mesh or grating should be used on all dry well openings to minimize damage caused by vandalism

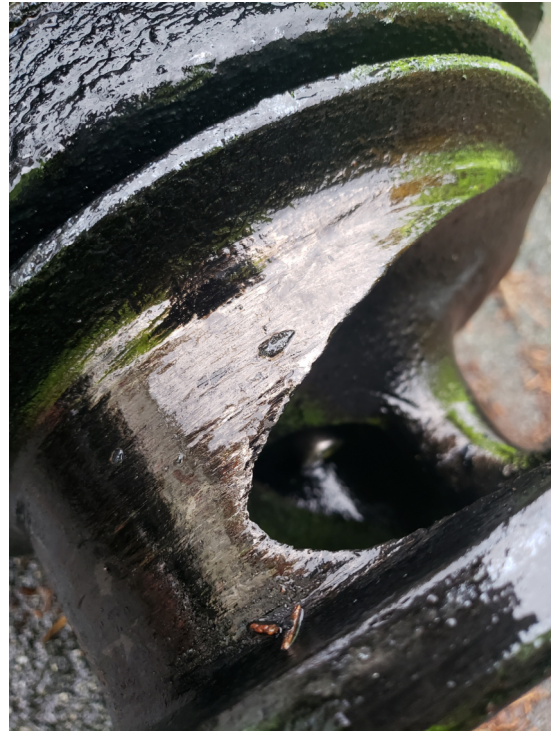
The Beach Comber lift station is in poor condition. The control panel is corroded through and could be allowing rainwater in. Both pumps demonstrated very low megohm readings. At the Beach Comber lift station, the low megohm readings could be a result of poor wire splicing practice or the pump motors could be failing. There are no seal offs on any of the conduits entering the control panel, which is likely contributing to corrosion of the control panel from the inside out. Additionally, there are no bollards or other protection from traffic, which is a concern as the lift station is located on the outside of a corner where vehicle traffic tends to speed. Pump 1 produced 128 gpm and pump 2 produced 116 gpm. Both pumps showed noticeable signs of wear on the impeller and volute. Coating on the wet well appears to be a urethane product and has failed. Some concrete aggregate was exposed in areas of coating failure in the wet well. Check valves and isolation valves within the valve vault were noted as old and having a corroded exterior, however the ductile iron discharge piping was in satisfactory condition. The Beach Comber lift station did not have a standby generator but did have a manual transfer switch and was connection ready. An overflow pipe located within the wet well was pointed out by operations staff, but it is unclear if the overflow pipe is plugged or where the outfall is located.

Figure 7. Reduced impeller profile and compromised impeller geometry due to wear in the Beach Comber lift station.

Notes- Megohm readings are very low and should be investigated for cause- failing motor or conduits/junction box full of water. Concrete needs coating. Noticeable wear on the pumps impellers and volutes.

- Investigate cause for low megohm reading
- Replace pumps
- Replace control panel enclosure
- Install electrical seal offs
- Install traffic protection around control panel – eg. bollards
- Re-coat lift station wet well
- Cap overflow pipe

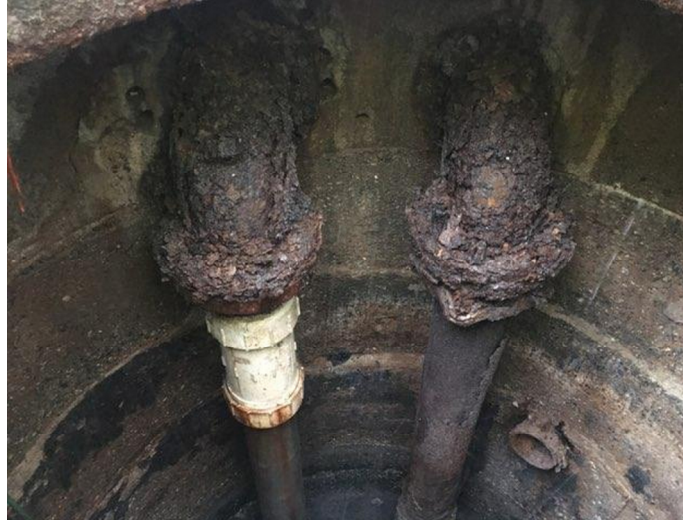
The #18 lift station is generally in poor condition. Megohm testing the two pumps in this lift station yielded very low resistance. The low reading should be investigated further for cause. Megohm testing could have been compromised due to poor splice quality and/or the junction box (where the splicing is) being full of water. Alternatively, the pump motors could be failing. Because the pumps were not installed on guide rails the pumps were not pulled. Therefore, the pump wet ends could not be inspected. Pump 1 produced 79 gpm and pump 2 produced 67 gpm. The isolation and check valves in the valve vault are old with exterior corrosion and the isolation valves were inoperable. The discharge piping showed signs of heavy corrosion. Similarly, the operations staff stated concern for integrity of the force main. The concern for the force main lies primarily in the fact that it is aged ductile iron and that it passes beneath some buildings whose foundation may be compromised if the force main is leaking. The wet well has aggregate within the concrete exposed. The #18 lift station did not have a standby generator onsite but does have a 70kW rated transfer switch installed with external point of connection for a portable generator.

Figure 8. Corroded discharge piping in lift station #18 wet well.

Corrosion- Heavy corrosion in wet well

- Replace lift station
- Investigate feasibility of eliminating lift station and flow by gravity to nearby sewer main
- Replace and relocate force main into public right of way
