**COASTAL BLUFF PROTECTION ANALYSIS  
and  
GEOTECHNICAL INVESTIGATION  
for  
Two Areas near Esplanade Park and the Area In-between  
Three Areas near Sea Palm Street  
Pacific Grove Recreational Trail  
Ocean View Boulevard  
Pacific Grove, California**

**Prepared for  
City of Pacific Grove  
Public Works Department**

**Prepared By  
HARO, KASUNICH AND ASSOCIATES, INC.  
Geotechnical & Coastal Engineers  
Project No. M10997  
December 2016**

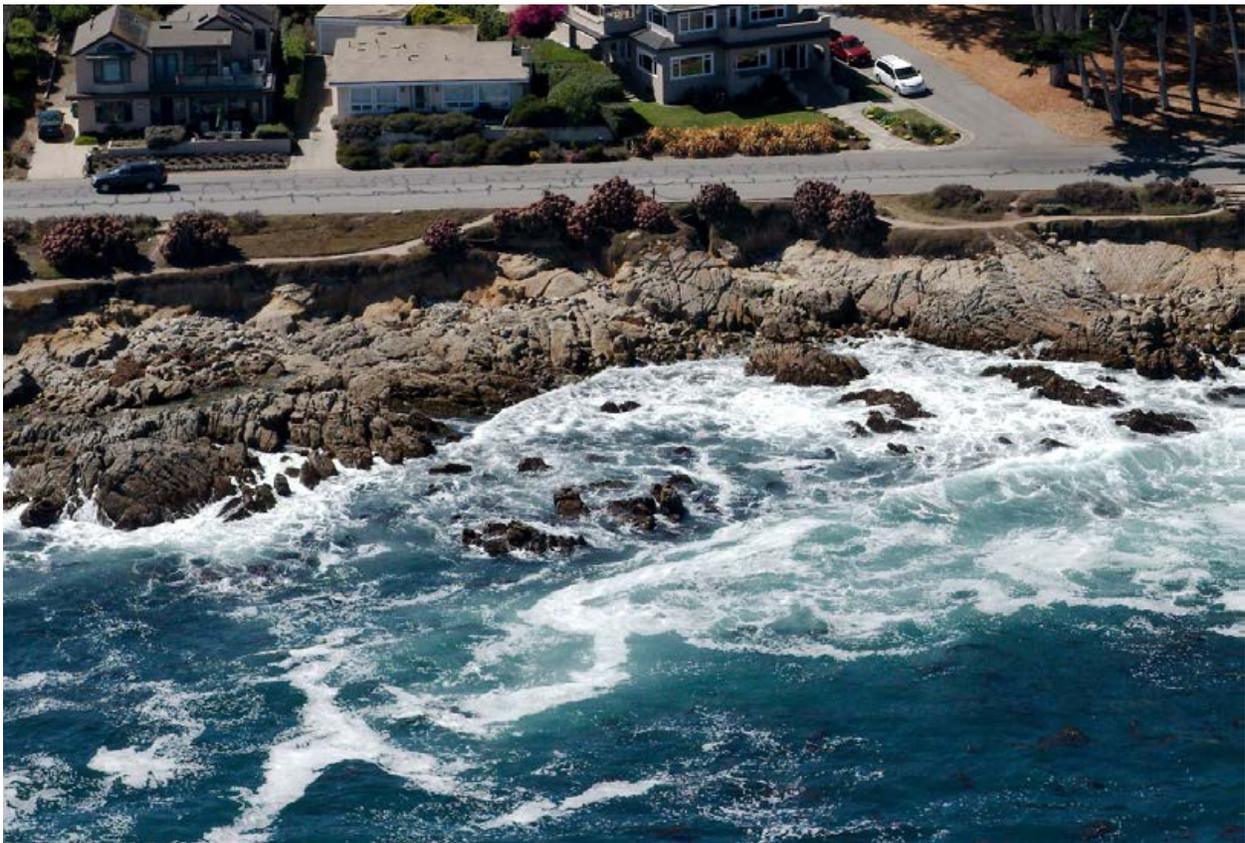
The Trail is threatened in the locations either side of Esplanade East, where it is located immediately adjacent to the bluff edge. In these area there is adequate room to relocate the trail inland away from the coastal bluff edge.

**Figure 7: 2013 Photo of Locations on Either Side of Esplanade East  
Where the Trail is now at the Edge of Bluff  
(Esplanade East Is in Center of Photograph)  
(courtesy of [www.californiacoastline.org](http://www.californiacoastline.org))**

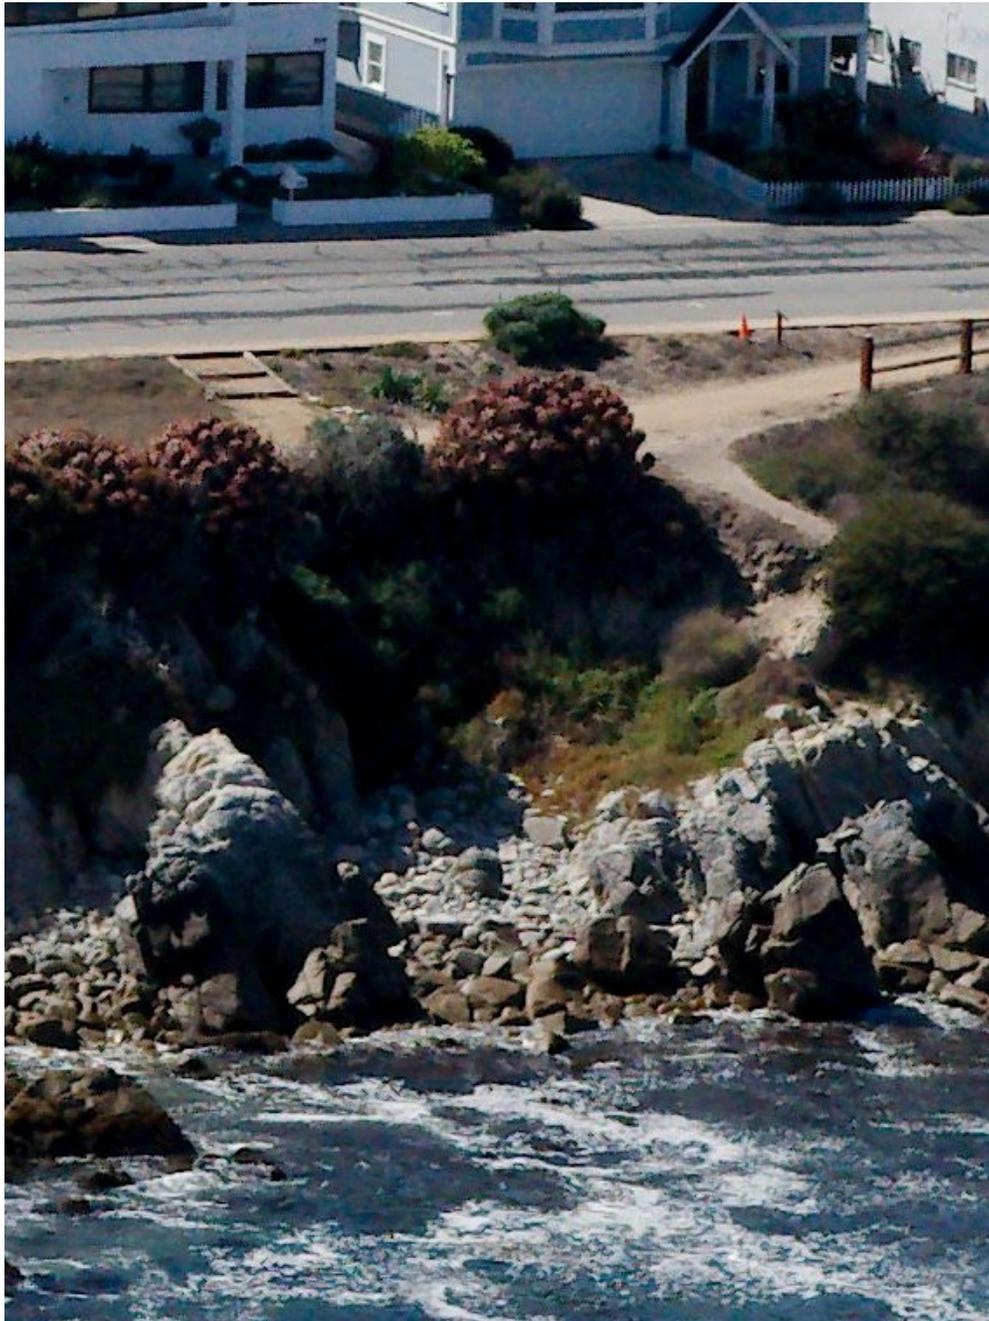
At the Sea Palm Central Area the bluff has receded landward due to repeated ocean wave impact. At the top of the bluff, the public access path is on the verge of being undermined. The bluff has receded landward due to repeated ocean wave impact that flows up a cobble beach and impacts the bluff. The upper portion of the coastal bluff has a very steep slope within the terrace deposits; and the public access path is being undermined. Some bedrock is exposed in the lower portion of the bluff face. The bluff extends down to the back edge of the beach. The area of concern is about 30 feet wide. It may be possible to realign the trail since the bluff edge is approximately 25 feet from the adjacent roadway. Below are photographs that show the Sea Palm Central area:

Figure 10: 2013 Sea Palm Central Area Aerial Photo Oblique View looking South  
(courtesy of [www.californiacoastline.org](http://www.californiacoastline.org))

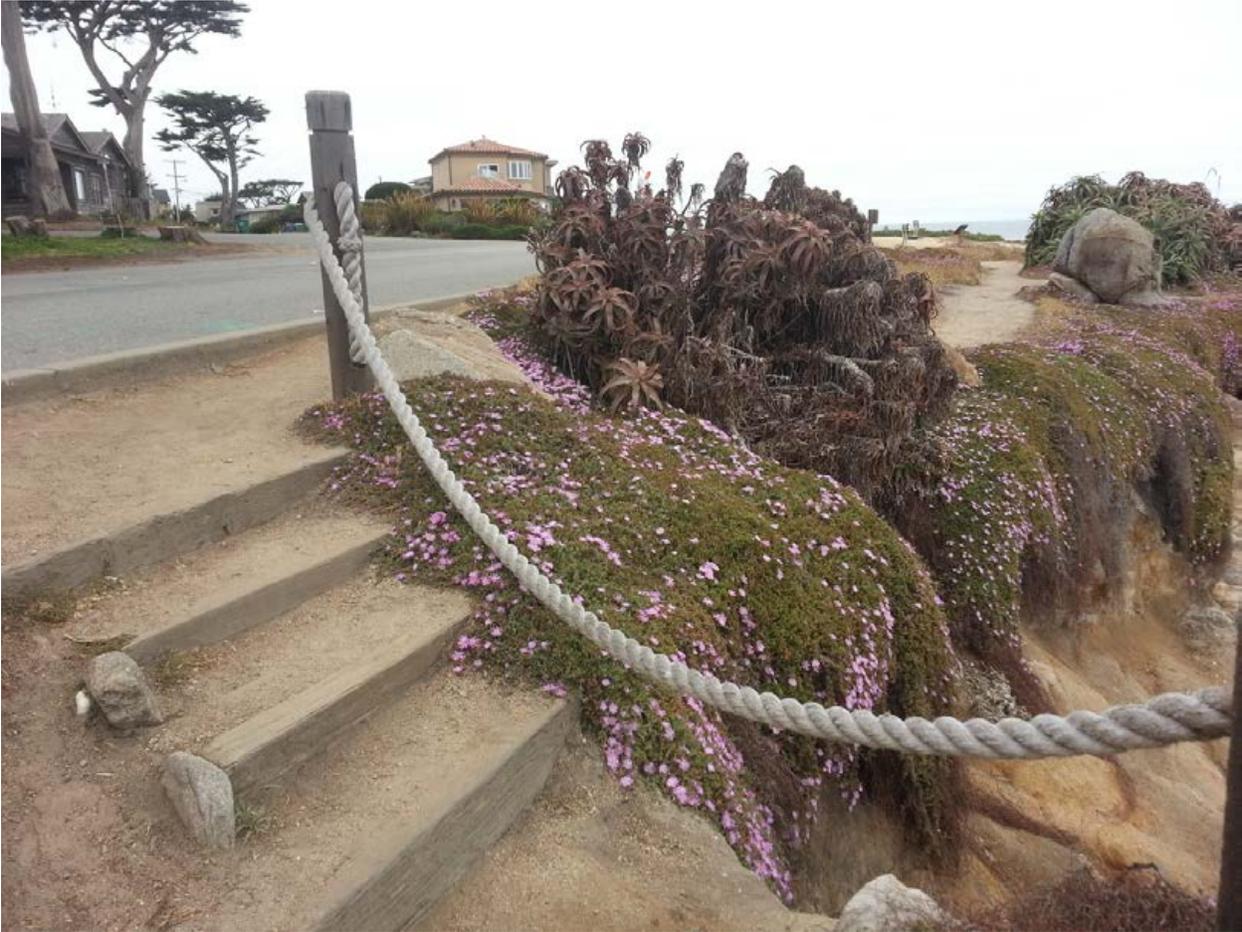
In this area the Trail is subject to episodic erosion damage, whether in a single strong storm, or in a series of storms occurring during 1 to 3 winter seasons, erosion may occur that results in several (3 to 8) feet of bluff retreat.

**Figure 14: Eroded Area as seen from Trail Looking Downcoast (Esplanade West)**

The recommended alternative is to construct a 20 foot long artificial rock blufftop seawall, 8.5 feet in height as measured from the bottom of the keyway to the top, with 6 to 7.5 feet of wall height exposed. It will be faced with an artificial rock surface to resemble the adjacent natural bedrock outcrops. After this alternative is constructed, the Recreational Trail can be relocated seaward from its present position immediately on the edge of Ocean View Boulevard, providing greater safety for trail users (Appendix D Drawings 1 and 2). This alternative is depicted in Appendix C on Sheets 1, 2 and 3.

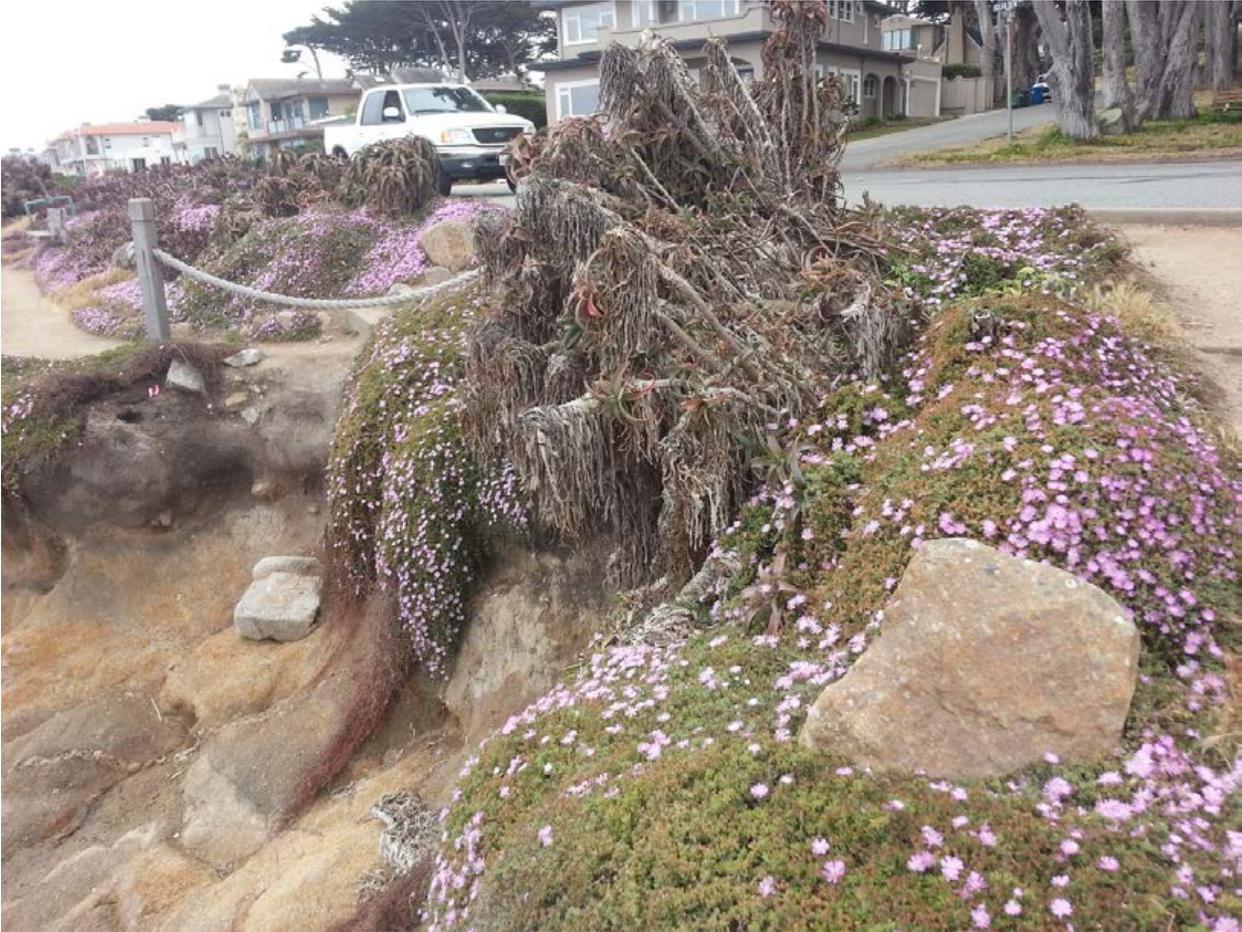
**Figure 15: Esplanade West Eroded Area as seen from Trail Looking Upcoast  
(Trail is along curb)**

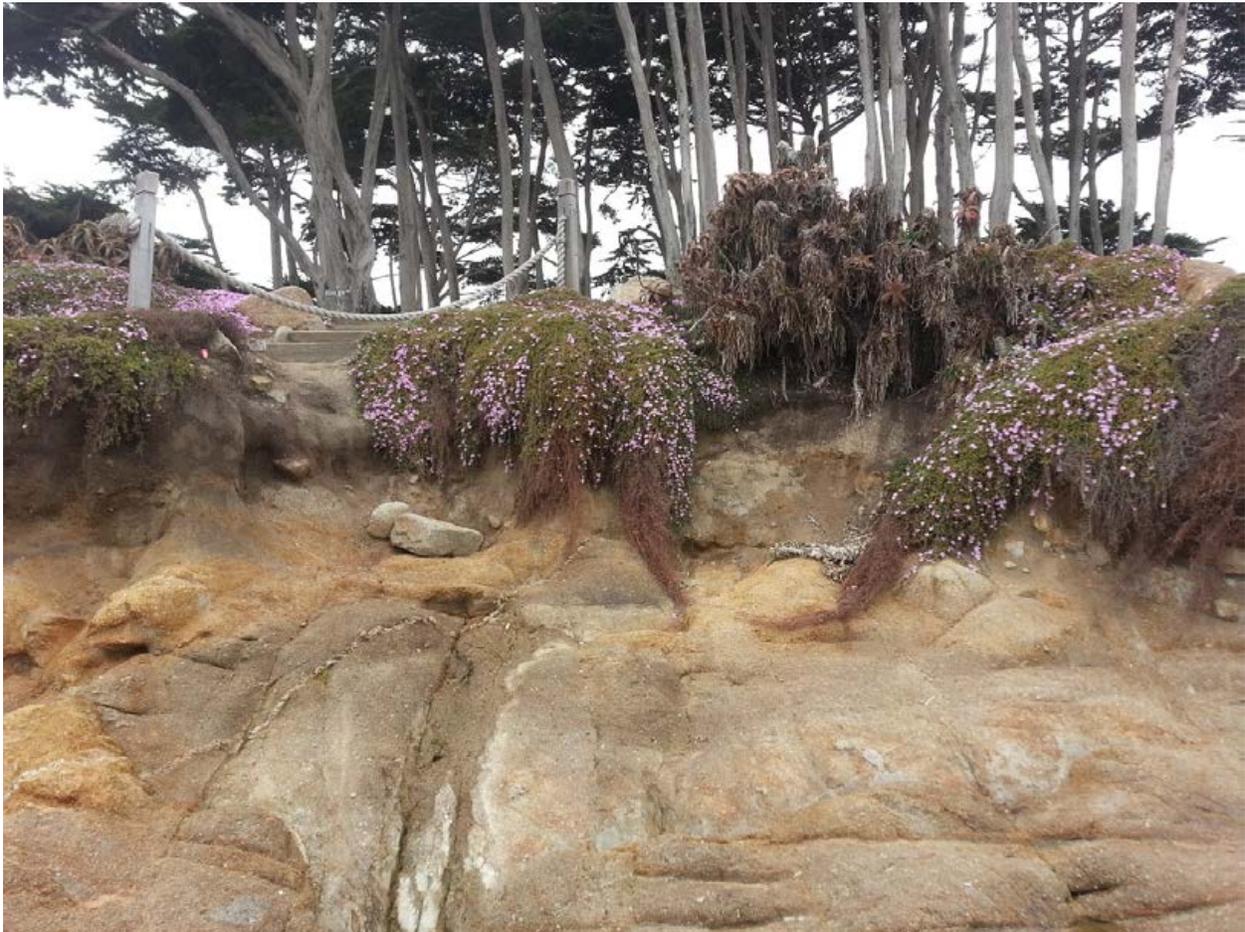
**Figure 16: Esplanade West Eroded Area as seen from Bedrock Platform  
Looking Landward (Trail is undermined at rope)**

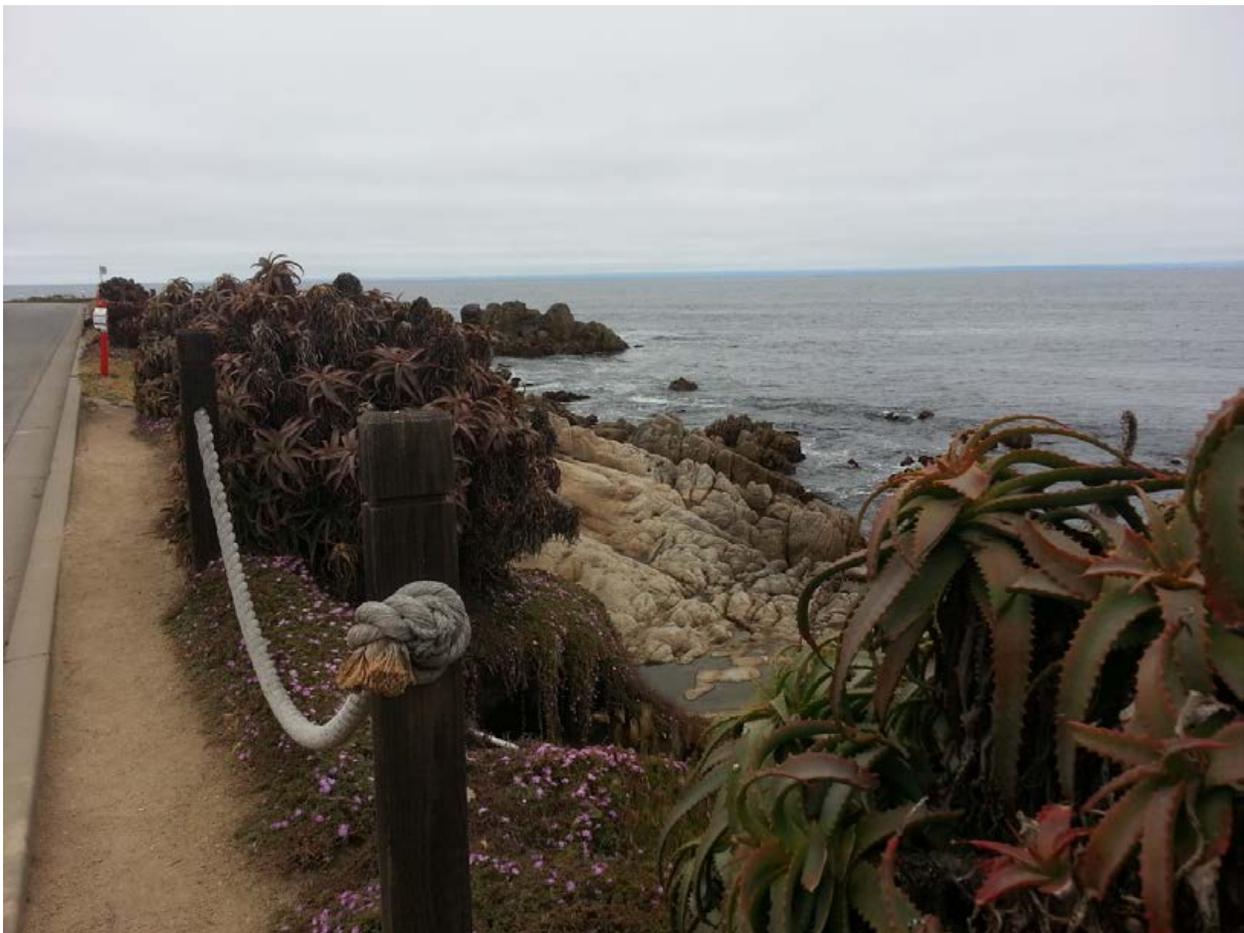
upper portion of the coastal bluff has a nearly vertical slope within the terrace deposits; and the public access path is being undermined. A water line has been damaged by erosion and has been patched. A few pieces of rip-rap were placed in the gully during winter 2015 to reduce the rate of erosion. Below are photographs that show the Esplanade East area:

**Figure 17: Trail along Bluff Edge at Eroded Area at Esplanade East**

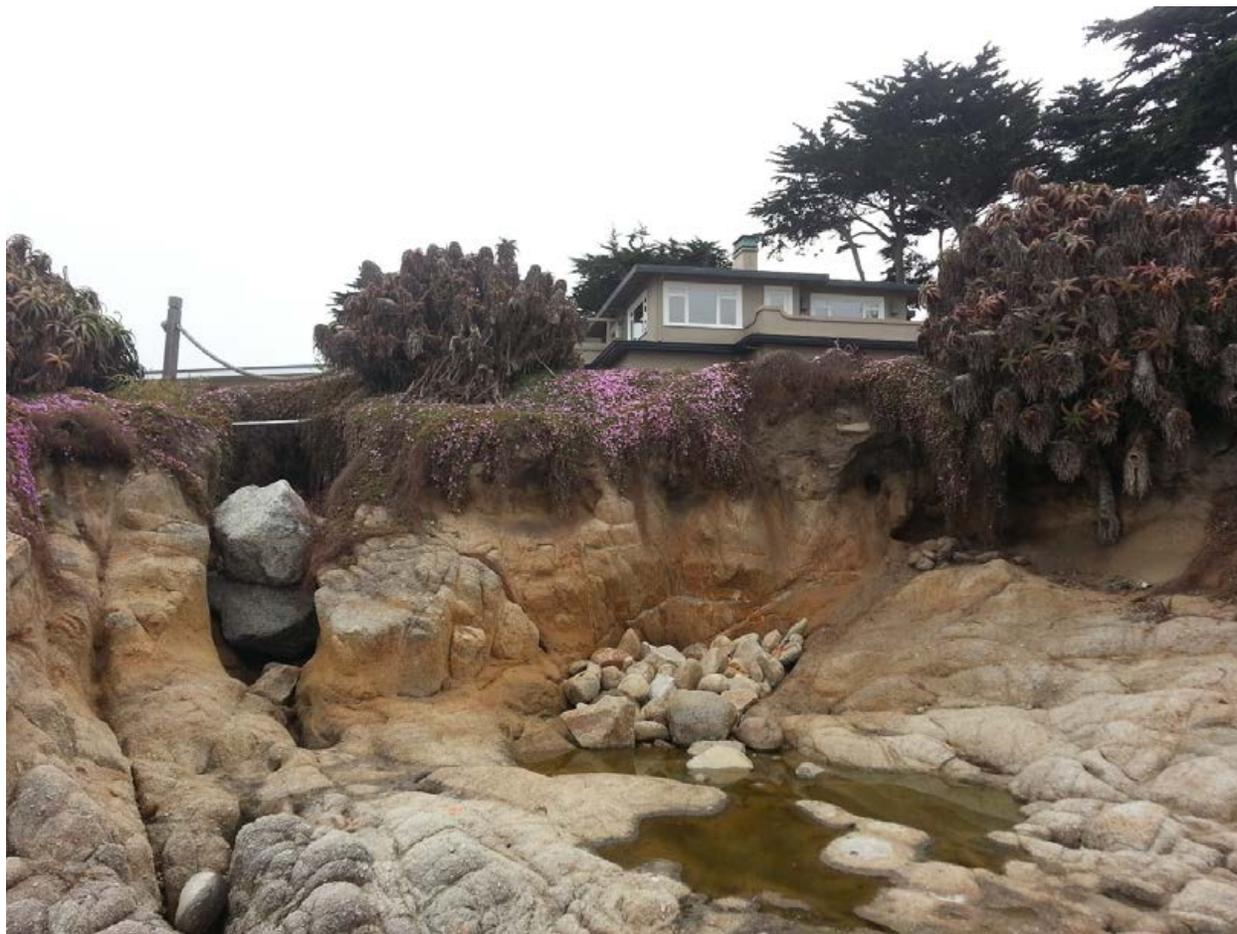
**Figure 18: Esplanade East Eroded Areas  
as seen from Bedrock Platform Looking Landward**

At Esplanade East the bluff edge is immediately adjacent to the Recreational Trail, a path which is frequently used by bicyclists and pedestrians. Landward of the path is Ocean View Boulevard, a two lane scenic road, used by residents and coastal visitors. If the bluff is left unsupported, the near-vertical bluff face will erode and the Trail will be undermined which will cut off access along the path. Ocean View Boulevard is presently in danger of erosion. Wave runup has contributed to the damage.

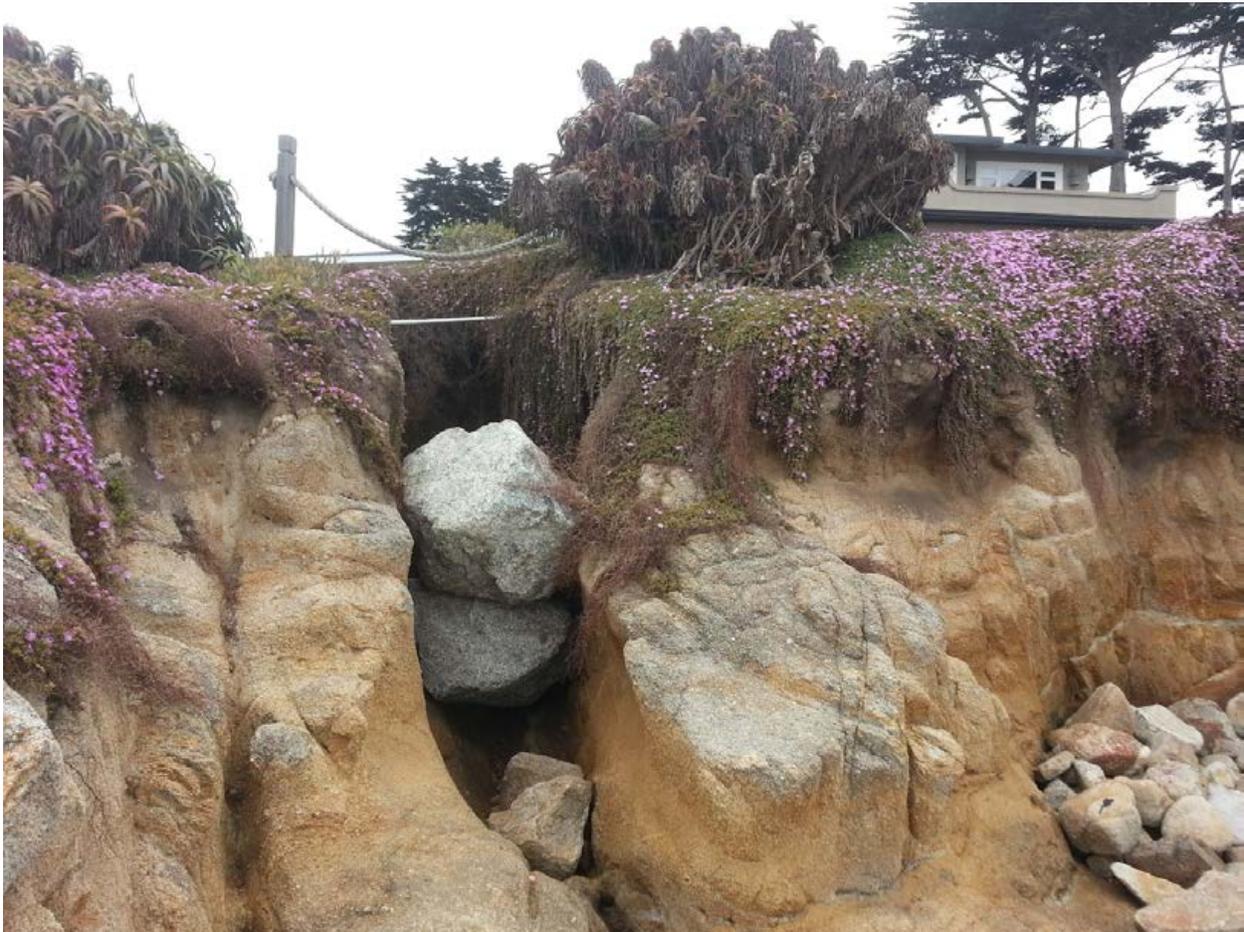
**Figure 19: Esplanade East Eroded Area as seen from Bedrock Platform  
Looking Landward (Emergency rip-rap boulders below waterline)**

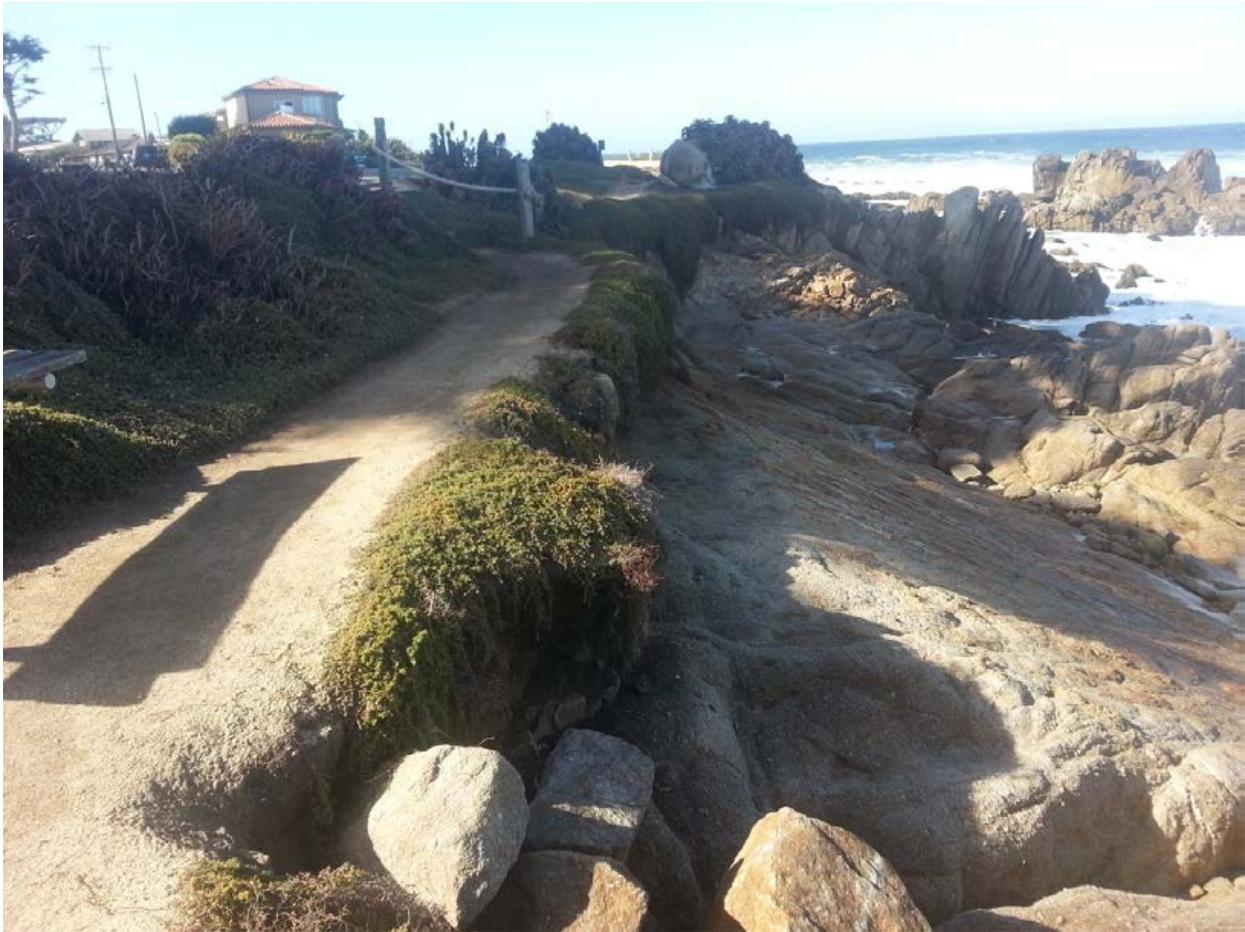
**Figure 21: Photo of Location Downcoast of Esplanade East  
Where the Trail is now at the Edge of Bluff  
And Trail Relocation is Feasible  
View Looking Downcoast**

adequate room to relocate the trail inland away from the coastal bluff edge. A drawing of the proposed relocations are shown in Appendix D Drawings 1, 2 and 3.

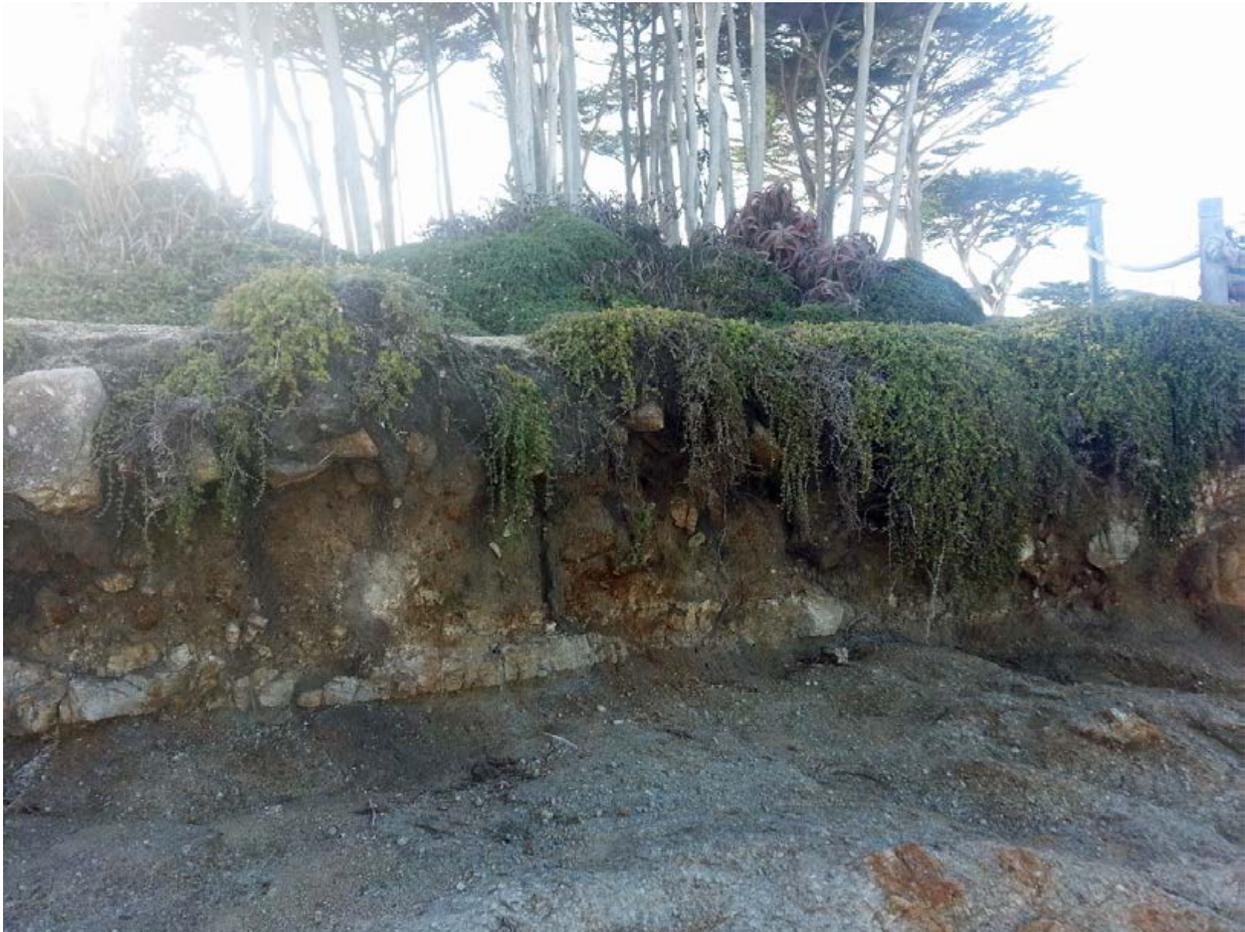
**Figure 22: Photo of Location Downcoast of Esplanade East  
Where the Trail is now at the Edge of Bluff  
And Trail Relocation is Feasible  
View from Bedrock Platform Looking Landward**

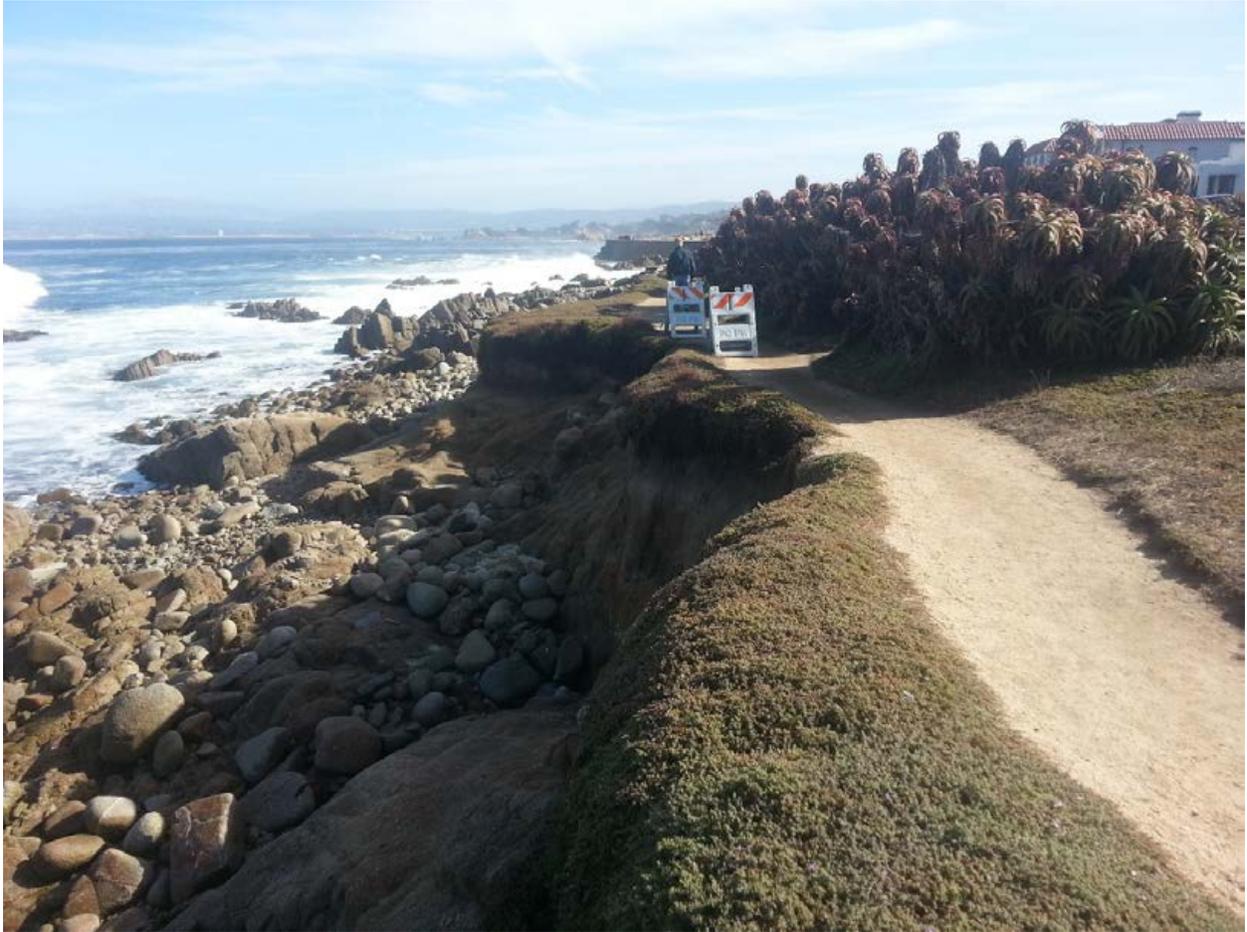
**Figure 23: Photo of Location Upcoast of Esplanade East  
Where the Trail is now at the Edge of Bluff  
And Trail Relocation is Feasible  
View Looking Upcoast**

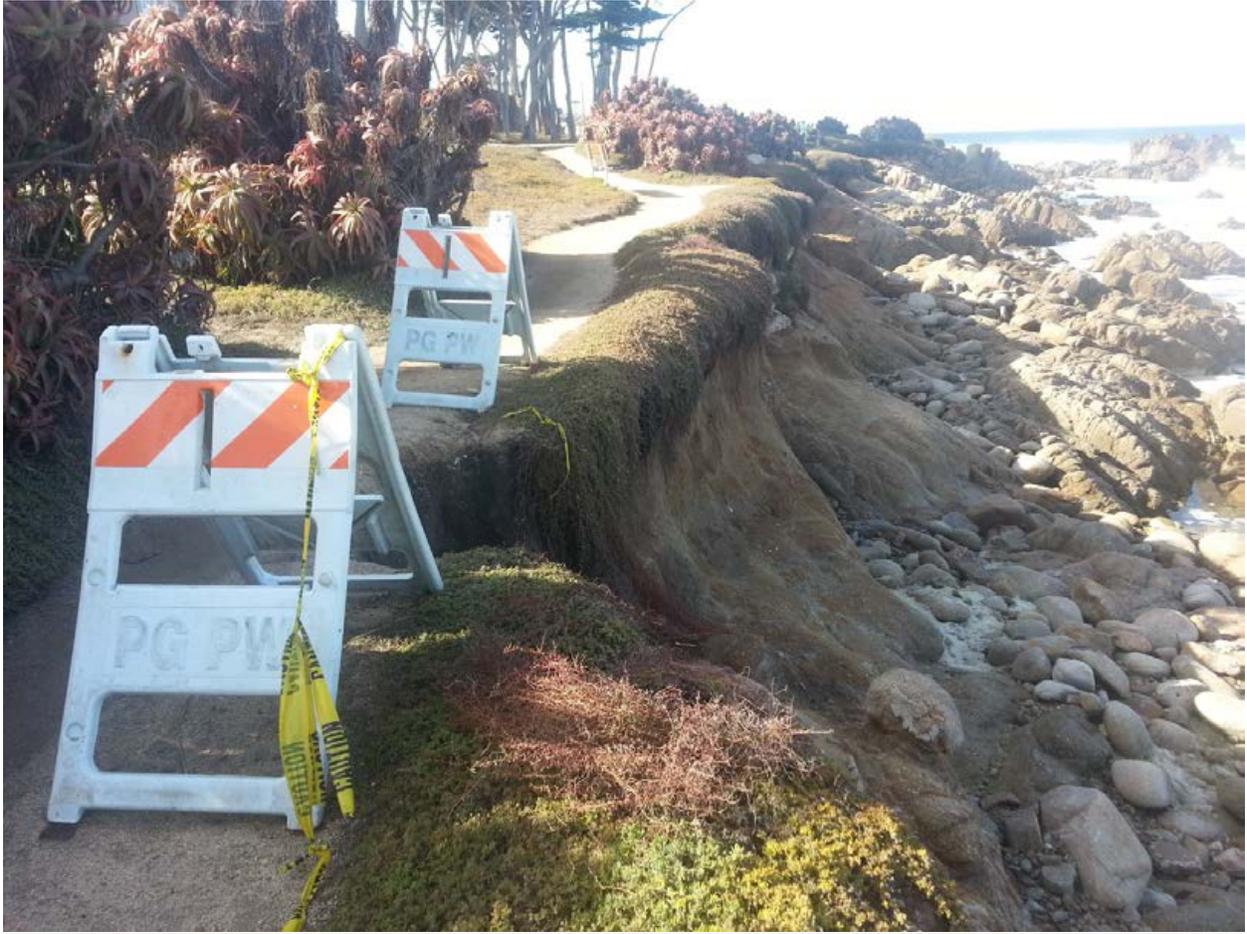
**Figure 24: Photo of Location Upcoast of Esplanade East  
Where the Trail is now at the Edge of Bluff  
And Trail Relocation is Feasible  
View Looking Downcoast**

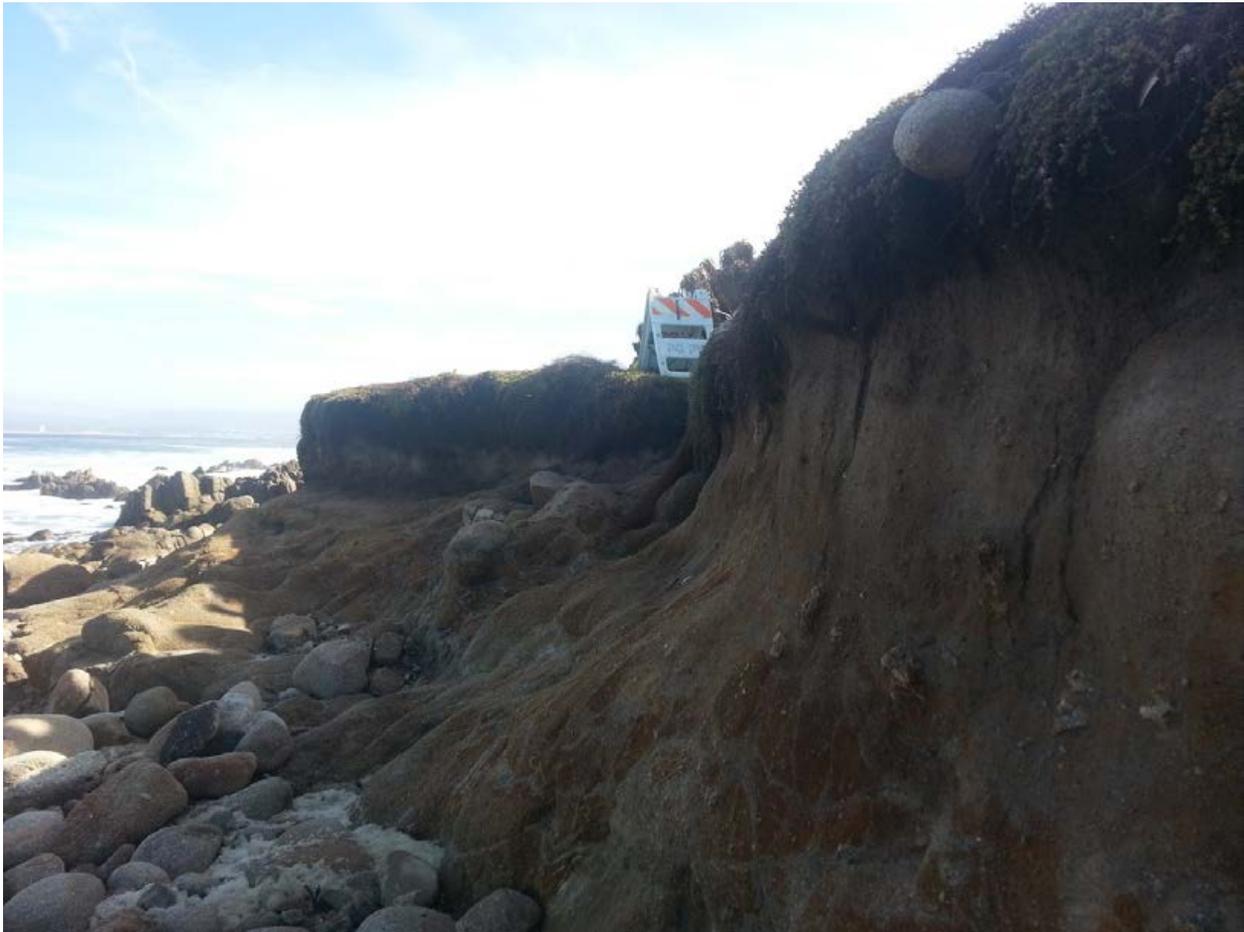
**Figure 25: Photo of Location Upcoast of Esplanade East  
Where the Trail is now at the Edge of Bluff  
And Trail Relocation is Feasible  
View from Bedrock Platform Showing Geology**

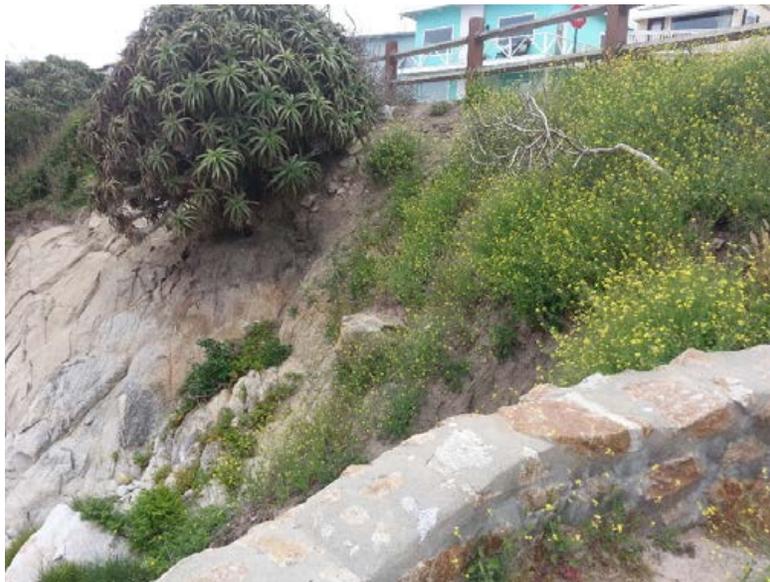
undermined. The bluff extends down to the back edge of the beach. The area upcoast (toward Monterey) was protected with an artificial rock seawall in 2007; at the same time, the beach access stairs were supported with artificial rock where they were undermined. The area of concern is about 30 feet wide. Below are photographs that show the Sea Palm West area:

**Figure 26: Sea Palm West Eroded Area as seen from Perkins Park Beach Stairs**

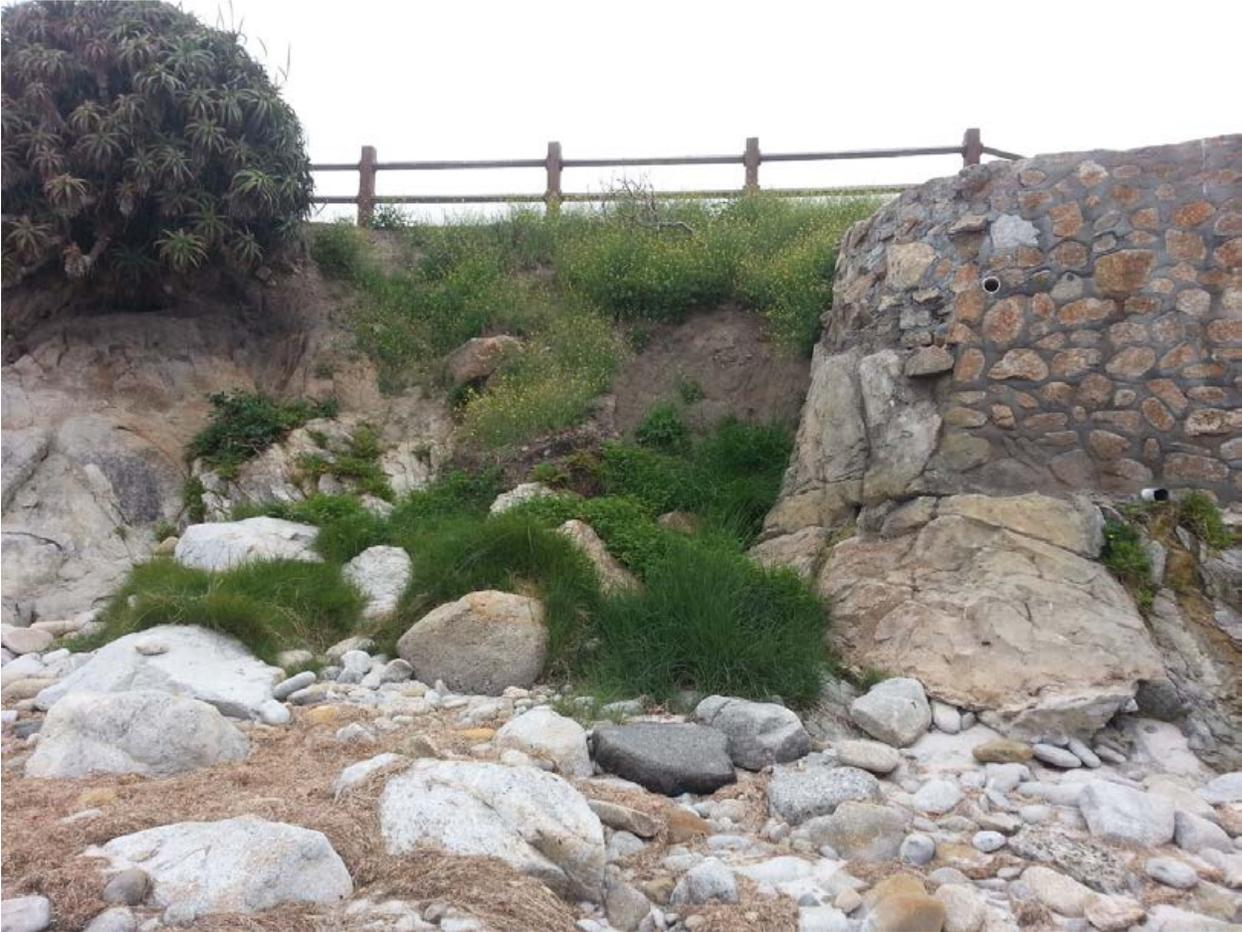
**Figure 27: Sea Palm West Eroded Area as seen from Beach**

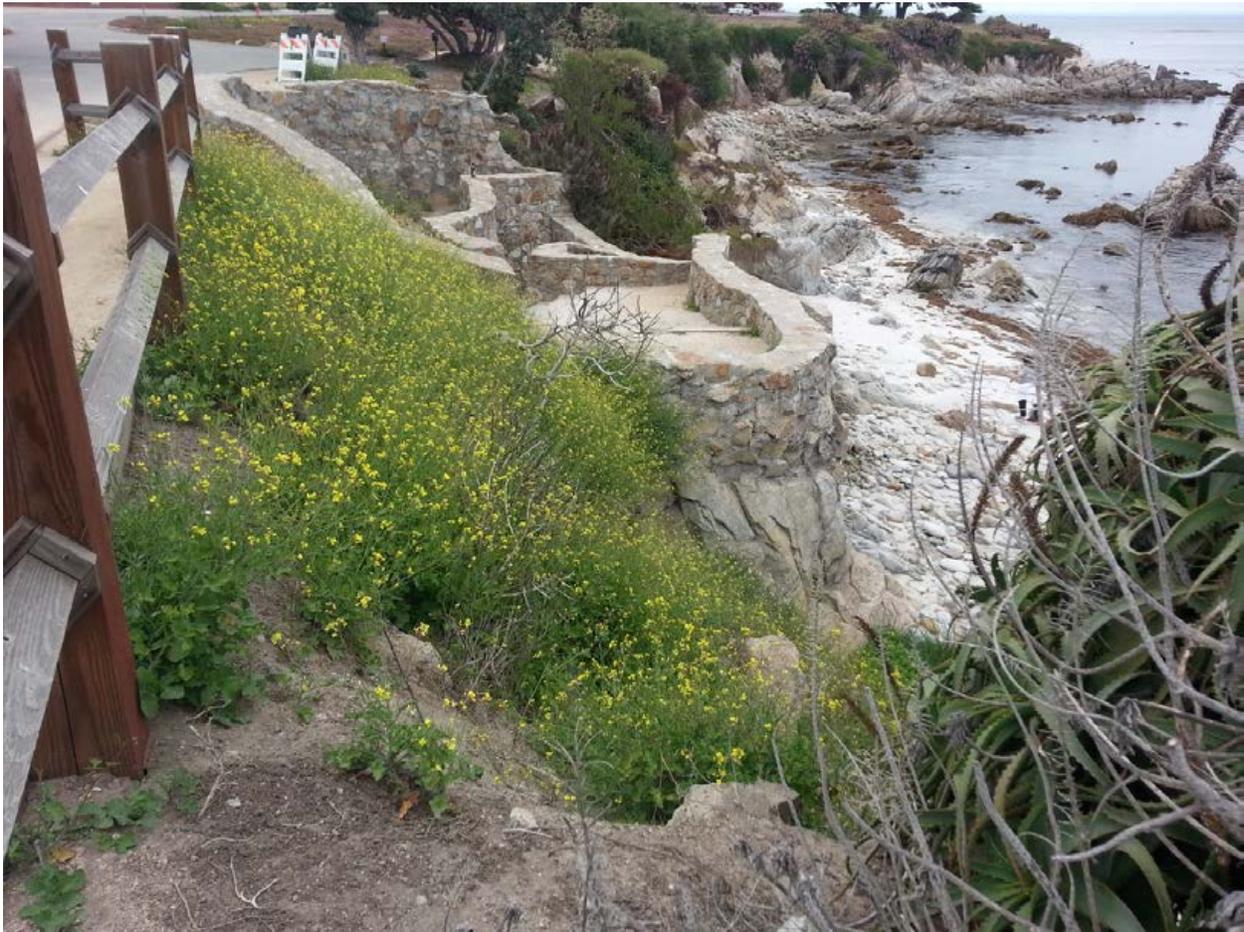
**Figure 28: Sea Palm West Eroded Area as seen from Trail Edge  
(Green Vegetation Covers Eroding Soil)**

contributed to the damage. There is no room to relocate the trail without relocating Ocean View Boulevard. The seaward edge of the trail is supported on topsoil and fill several feet deep.

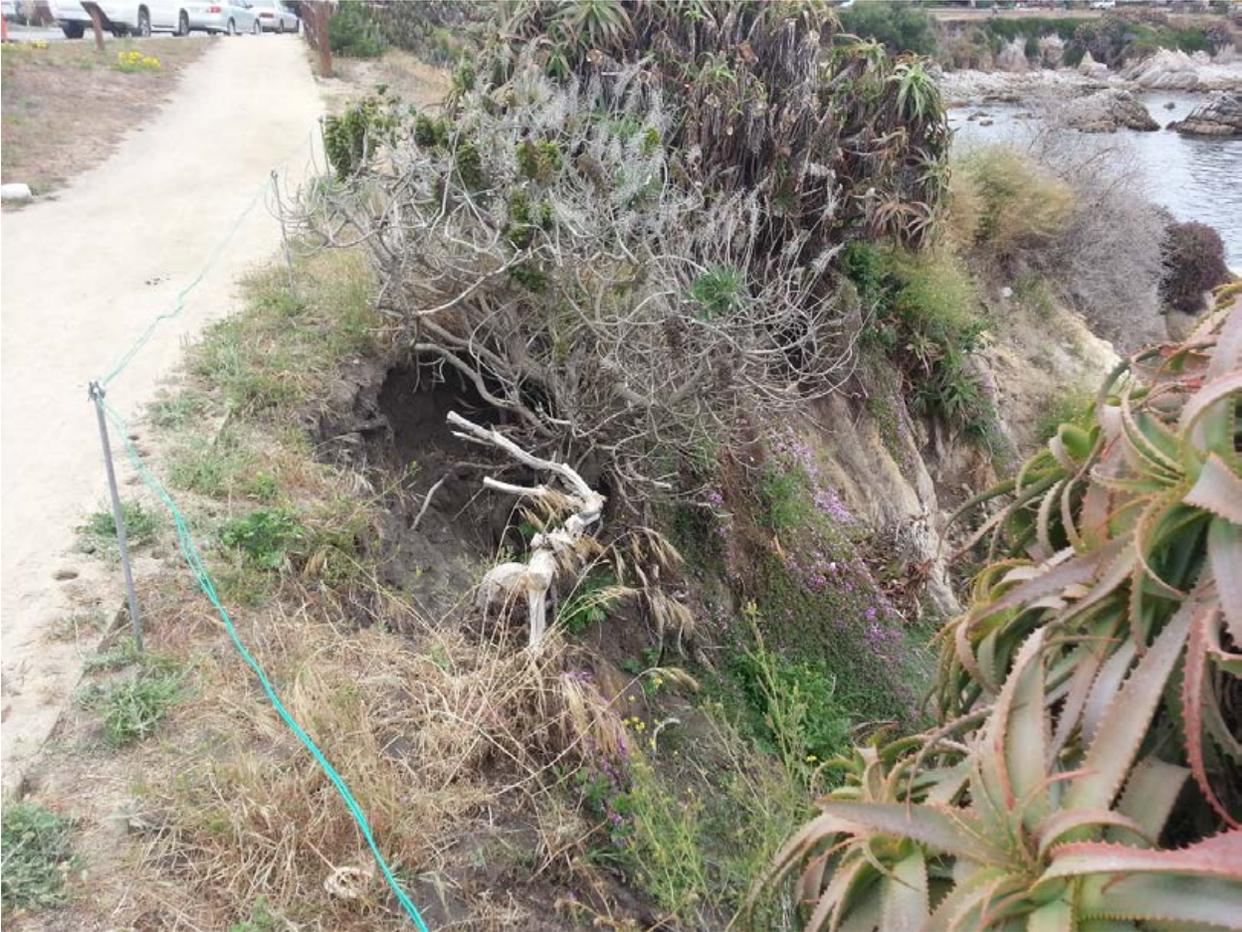
The Sea Palm Central area is about 270 feet towards Monterey from the Sea Palm Park beach stairs. At the Sea Palm Central Area the bluff has receded landward due to repeated ocean wave impact. At the top of the bluff, the public access path is on the verge of being undermined. The bluff has receded landward due to repeated ocean wave impact that flows up a cobble beach and impacts the bluff. The upper portion of the coastal bluff has a very steep slope within the terrace deposits; and the public access path is being undermined. Some bedrock is exposed in the lower portion of the bluff face. The bluff extends down to the back edge of the beach. The area of concern is about 30 feet wide. Below are photographs that show the Sea Palm Central area:

**Figure 29: Sea Palm Central Eroded Area as seen from Trail**

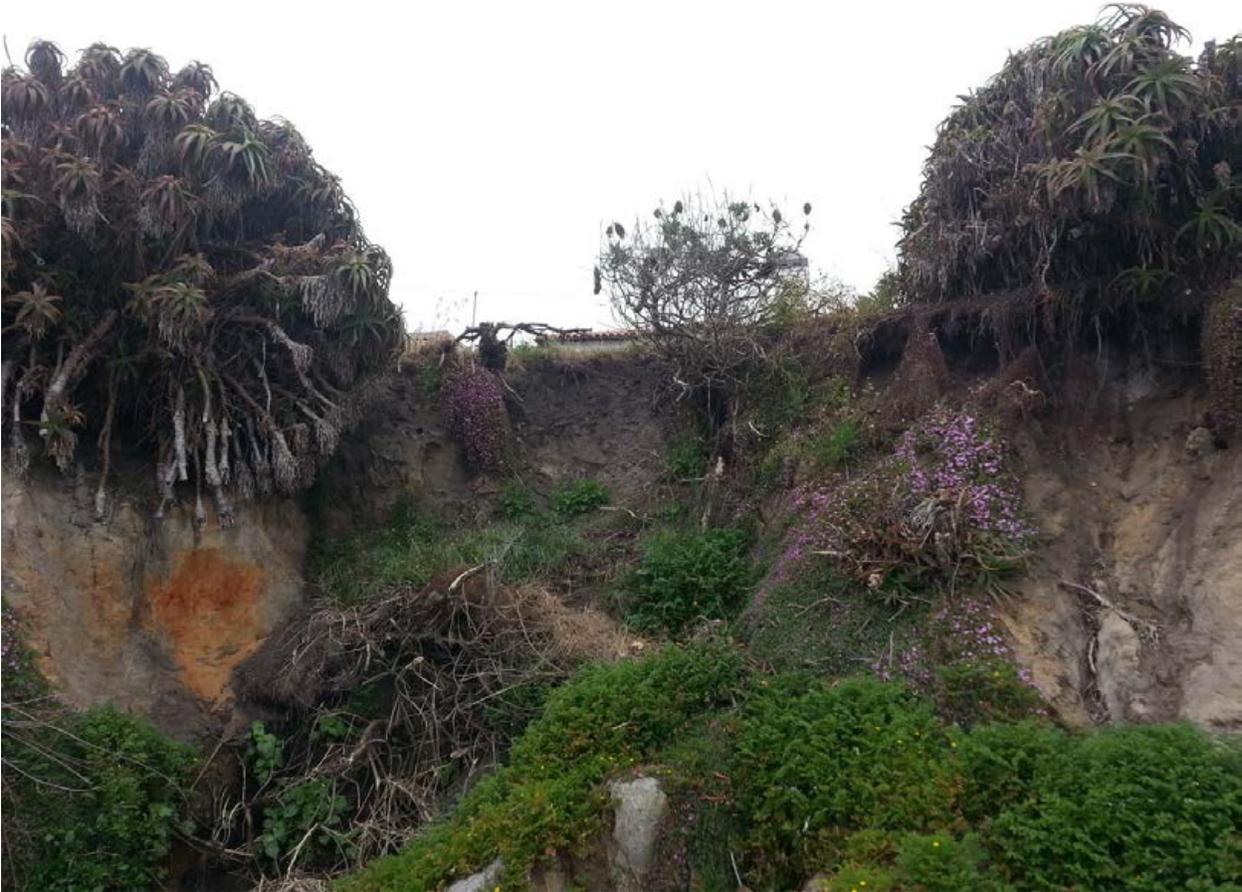
**Figure 30: Sea Palm Central Eroded Area as seen from Beach**

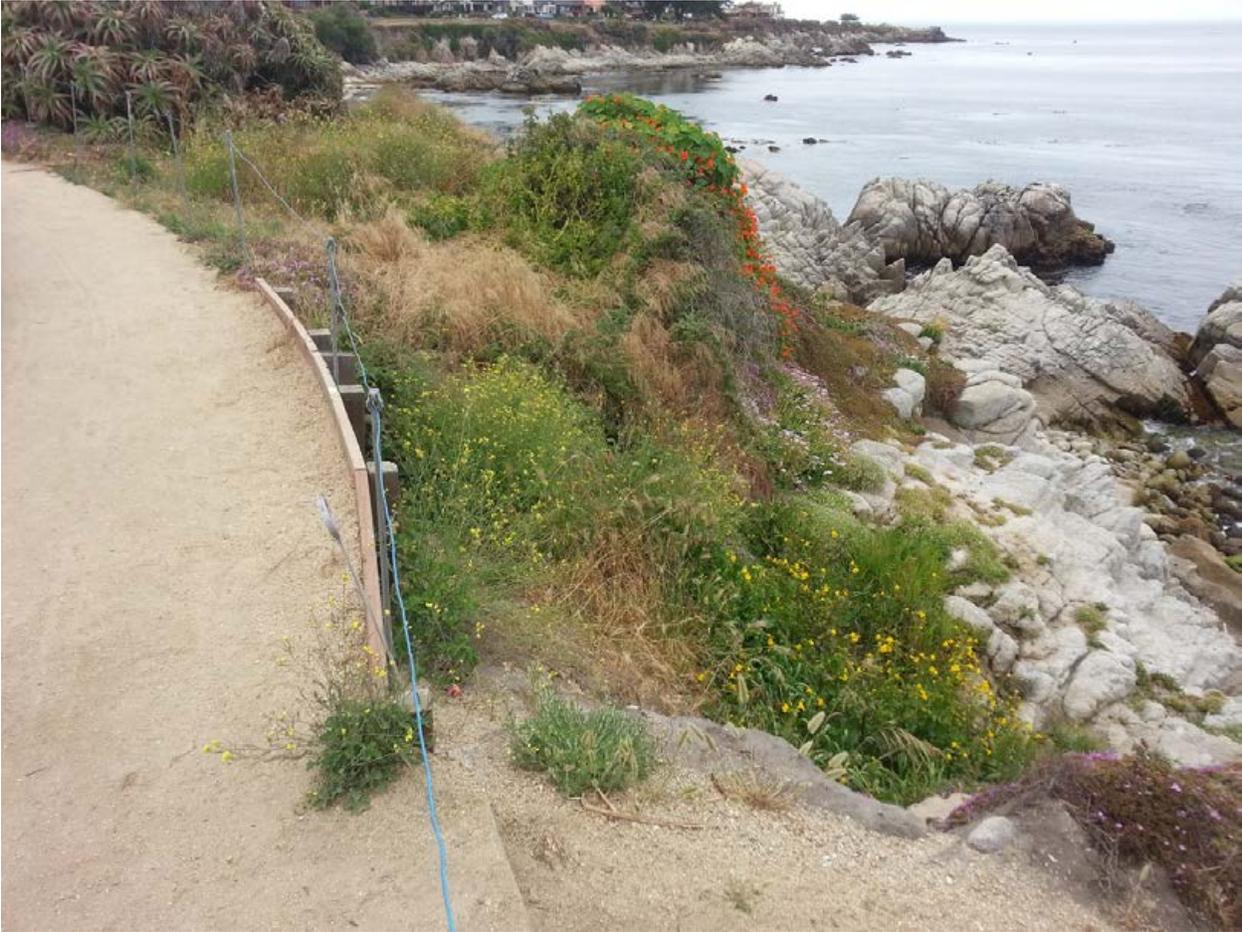
**Figure 32: Sea Palm East Eroded Area as seen from Trail**
