**COASTAL BLUFF PROTECTION ANALYSIS  
and  
GEOTECHNICAL INVESTIGATION  
for  
Two Areas near Esplanade Park and the Area In-between  
Three Areas near Sea Palm Street  
Pacific Grove Recreational Trail  
Ocean View Boulevard  
Pacific Grove, California**

**Prepared for  
City of Pacific Grove  
Public Works Department**

**Prepared By  
HARO, KASUNICH AND ASSOCIATES, INC.  
Geotechnical & Coastal Engineers  
Project No. M10997  
December 2016**

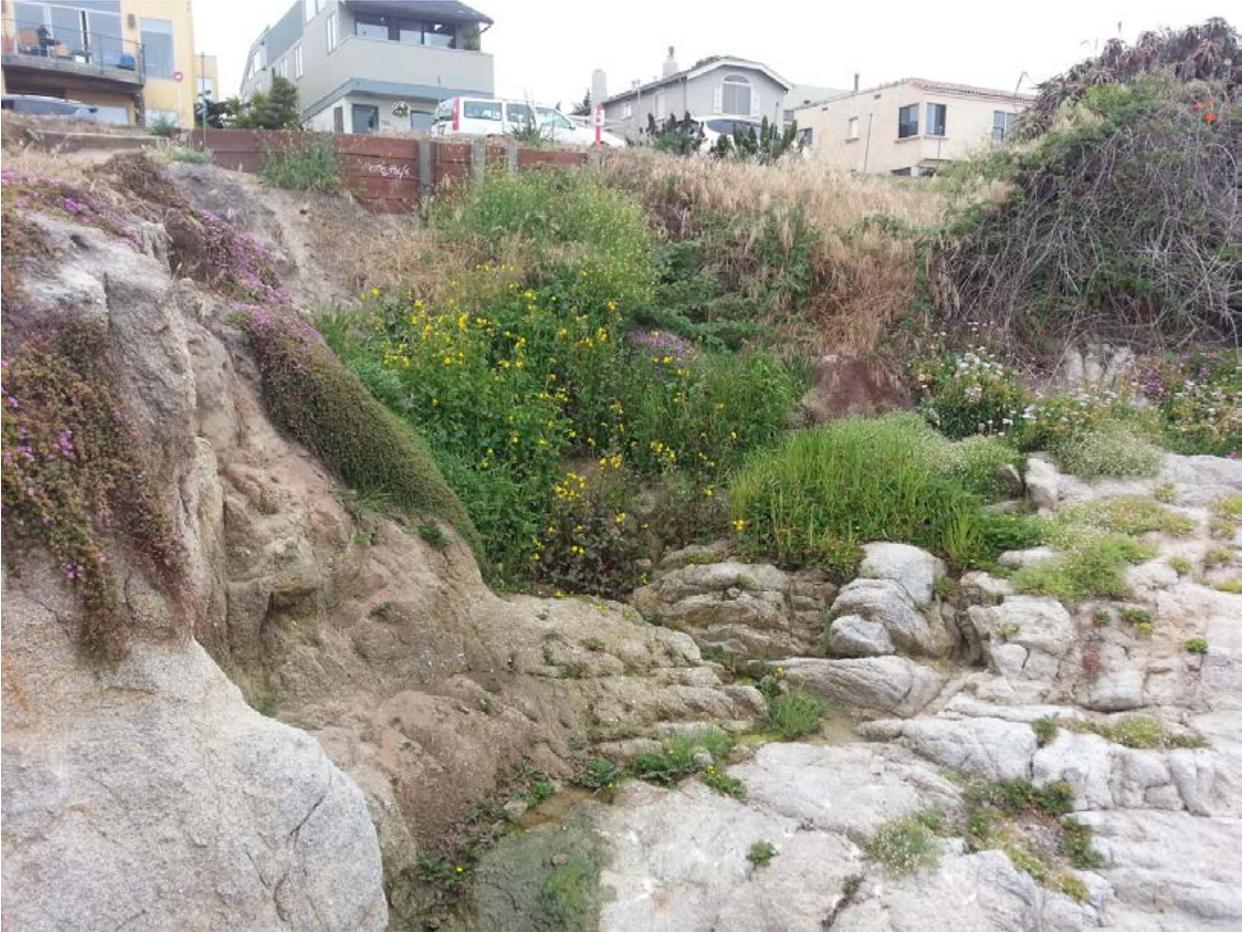
**Figure 33: Sea Palm East Eroded Area as seen from Beach**
