**COASTAL BLUFF PROTECTION ANALYSIS  
and  
GEOTECHNICAL INVESTIGATION  
for  
Two Areas near Esplanade Park and the Area In-between  
Three Areas near Sea Palm Street  
Pacific Grove Recreational Trail  
Ocean View Boulevard  
Pacific Grove, California**

**Prepared for  
City of Pacific Grove  
Public Works Department**

**Prepared By  
HARO, KASUNICH AND ASSOCIATES, INC.  
Geotechnical & Coastal Engineers  
Project No. M10997  
December 2016**

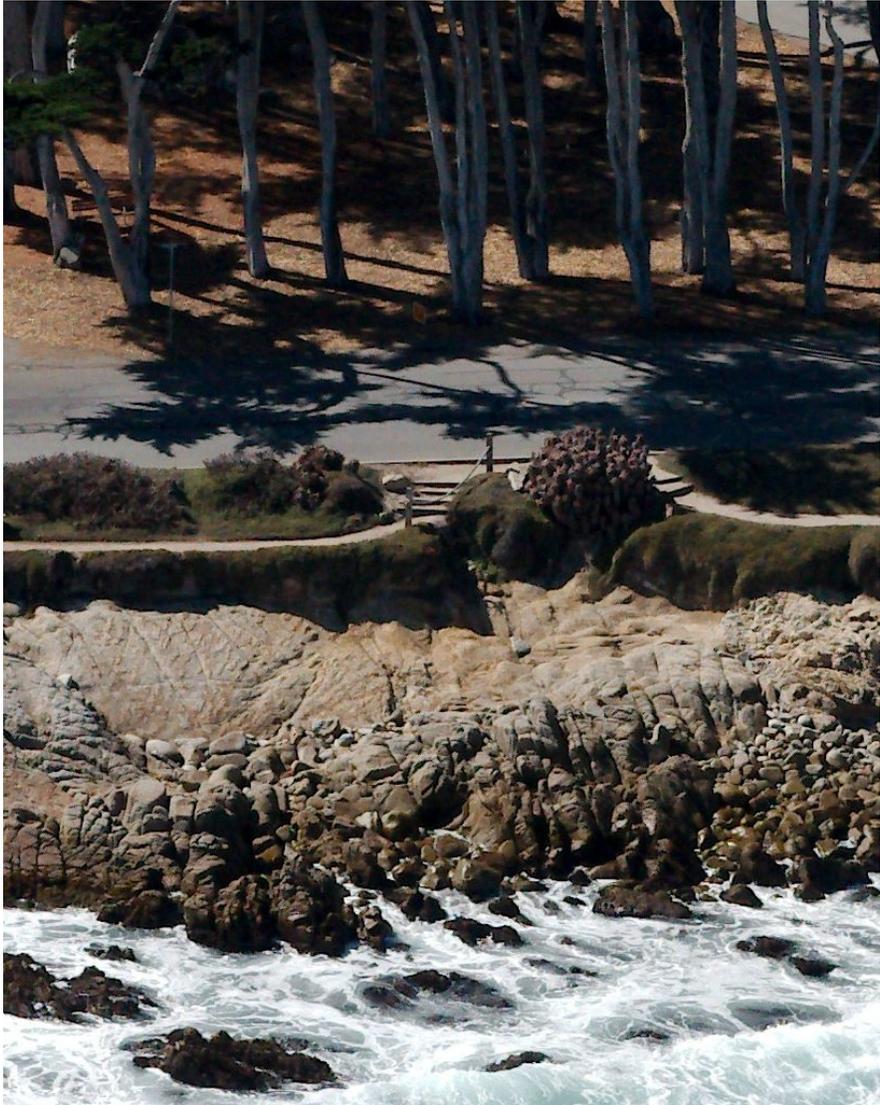
The Esplanade West Area is directly seaward of Esplanade Park. The area of concern is about 20 feet wide. Below are photographs that show the Esplanade West area:

**Figure 3: 2013 Esplanade West Area Oblique Aerial Photo View Looking South  
(courtesy of [www.californiacoastline.org](http://www.californiacoastline.org))**

The recommended alternative is to construct a 20 foot long artificial rock blufftop seawall, 8.5 feet in height as measured from the bottom of the keyway to the top, with 6 to 7.5 feet of wall height exposed. It will be faced with an artificial rock surface to resemble the adjacent natural bedrock outcrops. After this alternative is constructed, the Recreational Trail can be relocated seaward from its present position immediately on the edge of Ocean View Boulevard, providing greater safety for trail users (Appendix D Drawings 1 and 2). This alternative is depicted in Appendix C on Sheets 1, 2 and 3.

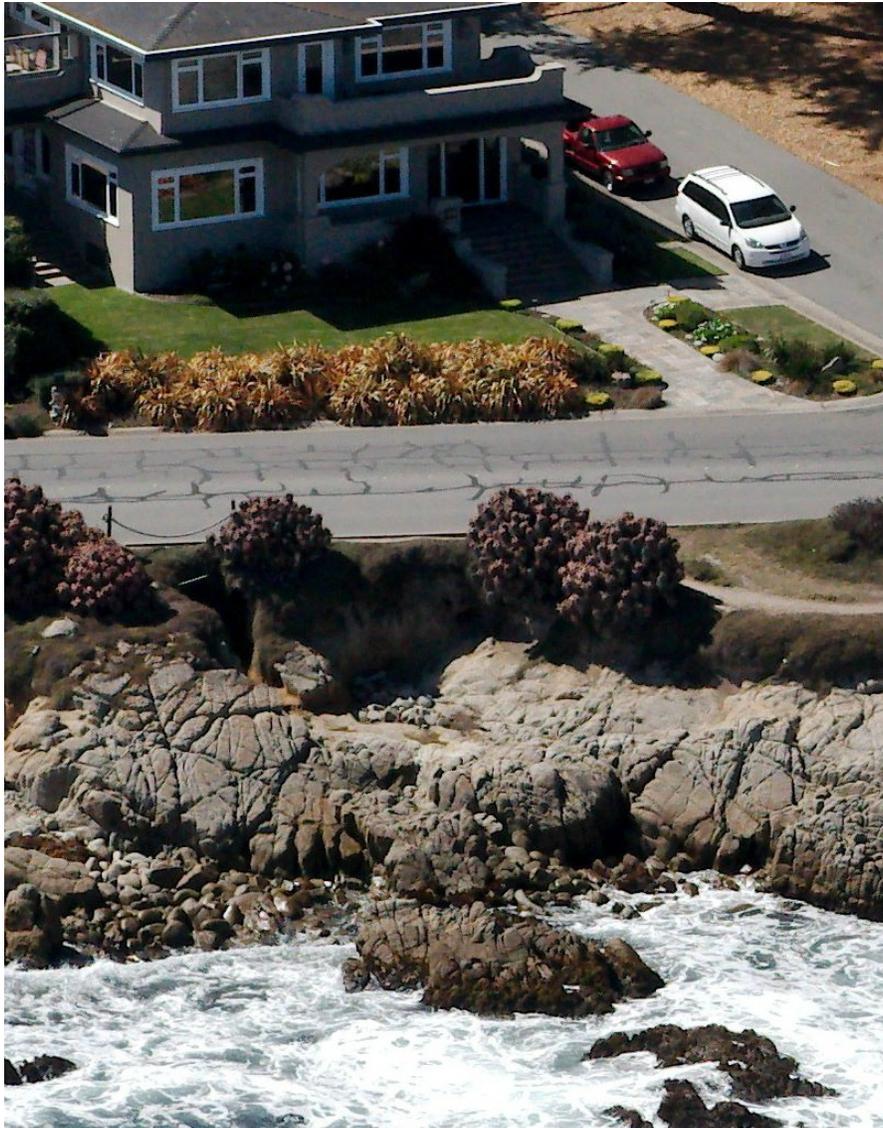
The Esplanade East area is about 100 to 180 feet towards Monterey from Esplanade West. The total area of concern is about 75 feet wide. Below are photographs that show the Esplanade East area:

**Figure 5: 2013 Esplanade East Area Oblique Aerial Photo View looking South**  
(The broad gully in the center of the photo has been referred to as Esplanade Central area in prior discussions. An exposed white water line is visible at the Esplanade East area to the left. Together the entire eroded area pictured is referred to in this report as Esplanade East)  
(courtesy of [www.californiacoastline.org](http://www.californiacoastline.org))

This Alternative considers and recommends the construction of the artificial rock faced seawalls depicted in Appendix C at Esplanade West (Sheets 1, 2 and 3), Esplanade East (Sheets 4,5 and 6) and Sea Palm West (Sheets 7 and 8).

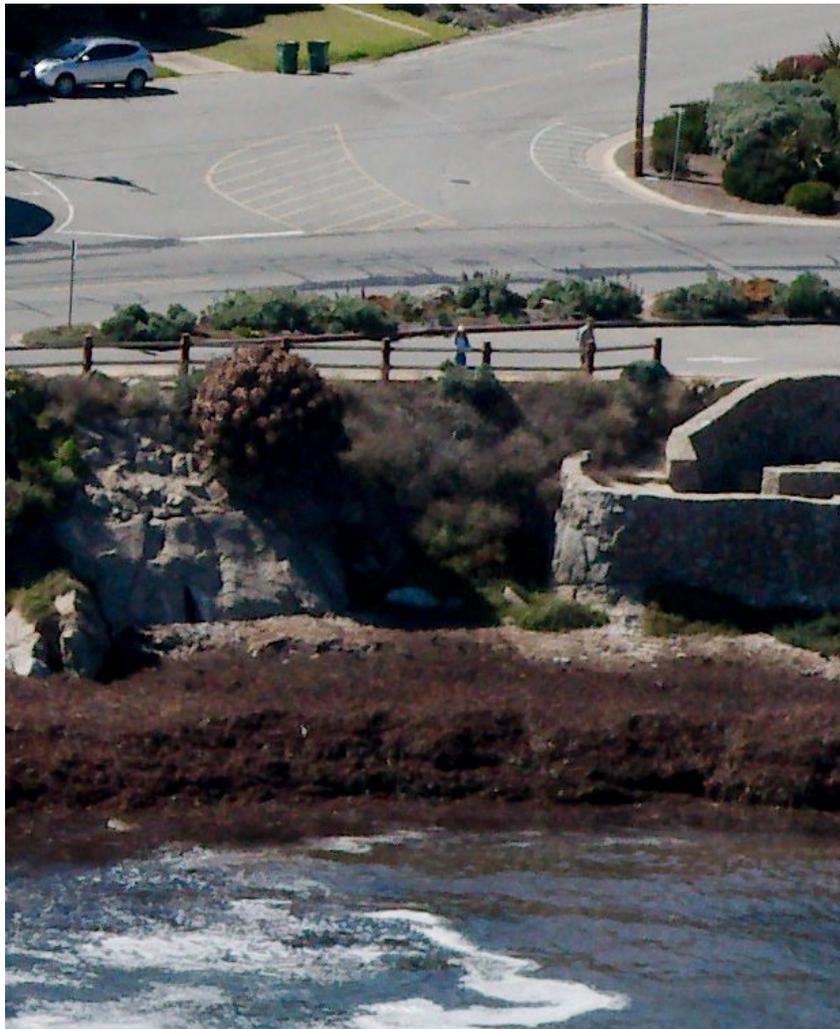
**Figure 8: 2015 Sea Palm West Area Oblique Aerial Photo View looking South  
(courtesy of [www.californiacoastline.org](http://www.californiacoastline.org))**

have been over-steepened relative to their height by historical erosion. This is especially true at Sea Palm West where the weaker earth materials, which include some fill soils from trail construction that are exposed at the bluff edge, extend almost all the way down to the elevation of the landward edge of the beach. Our qualitative slope stability analysis and observations of recent bluff face erosion indicate the segment of recreational trail adjacent to the bluff edge in the three Sea Palm Street areas is in danger from erosion, and may be damaged in a single winter ocean storm season. The bluff is subject to episodic erosion damage, whether in a single strong storm, or in a series of storms occurring during 1 to 3 winter seasons, erosion that results in several (3 to 8) feet of bluff retreat occurs, with greater amounts of probable retreat where the terrace and topsoils are thicker and where wave energy is concentrated due to the geomorphology. Sea Palm West is particularly subject to erosion risk because of the soft soils that form most of the bluff face there.

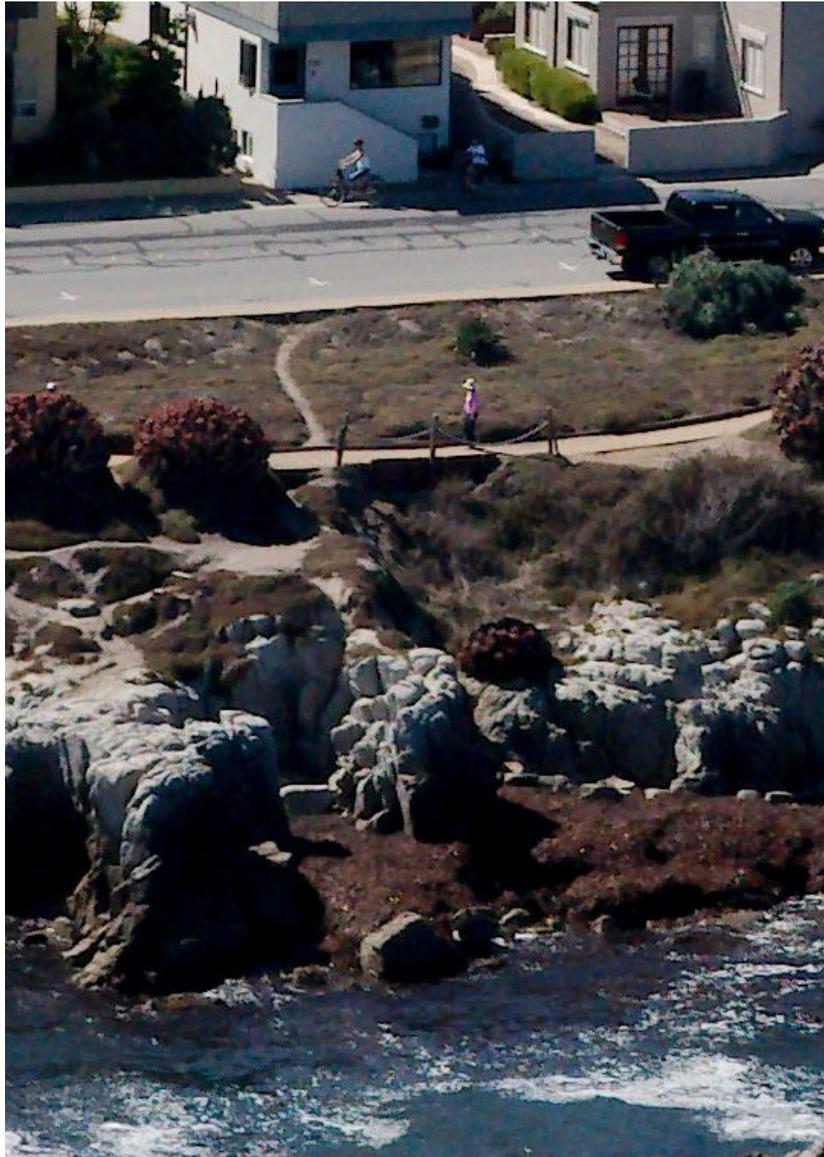
The Sea Palm East area is about 445 feet towards Monterey from the Sea Palm Park beach stairs. Below are photographs that show the Sea Palm East area:

**Figure 12: 2013 Sea Palm East Area Oblique View Aerial Photo looking South (courtesy of [www.californiacoastline.org](http://www.californiacoastline.org))**

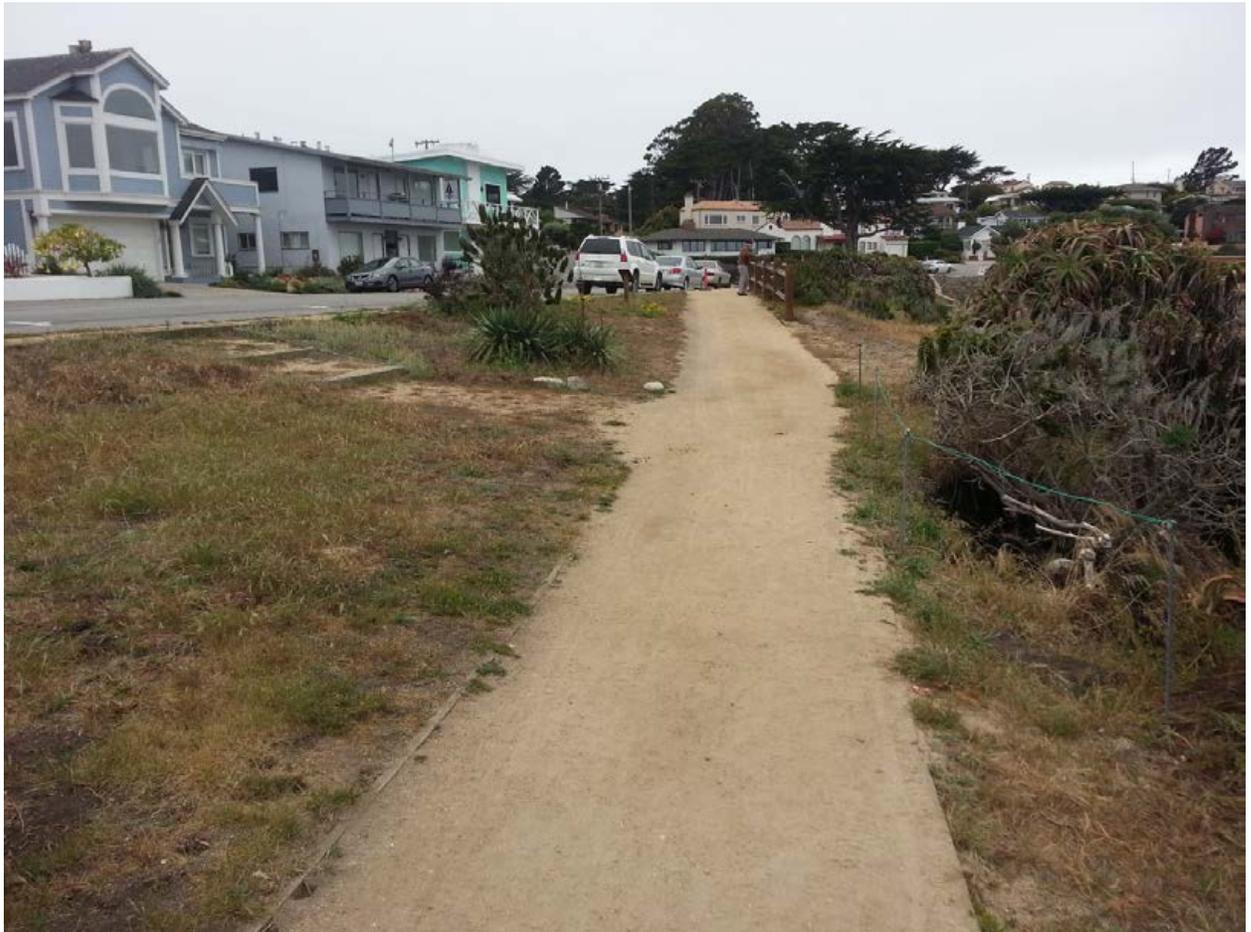
**Figure 31: Existing Trail and Ocean View Boulevard at Sea Palm Central**

At Sea Palm Central, the Recreational Trail is presently in danger from erosion, however Ocean View Boulevard is not in danger. It appears feasible to realign the trail since the bluff edge is approximately 28 feet from the adjacent roadway and there is ample room to do so, as shown in Figure 31. This alternative is depicted in Appendix C on Sheets 9 and 10.

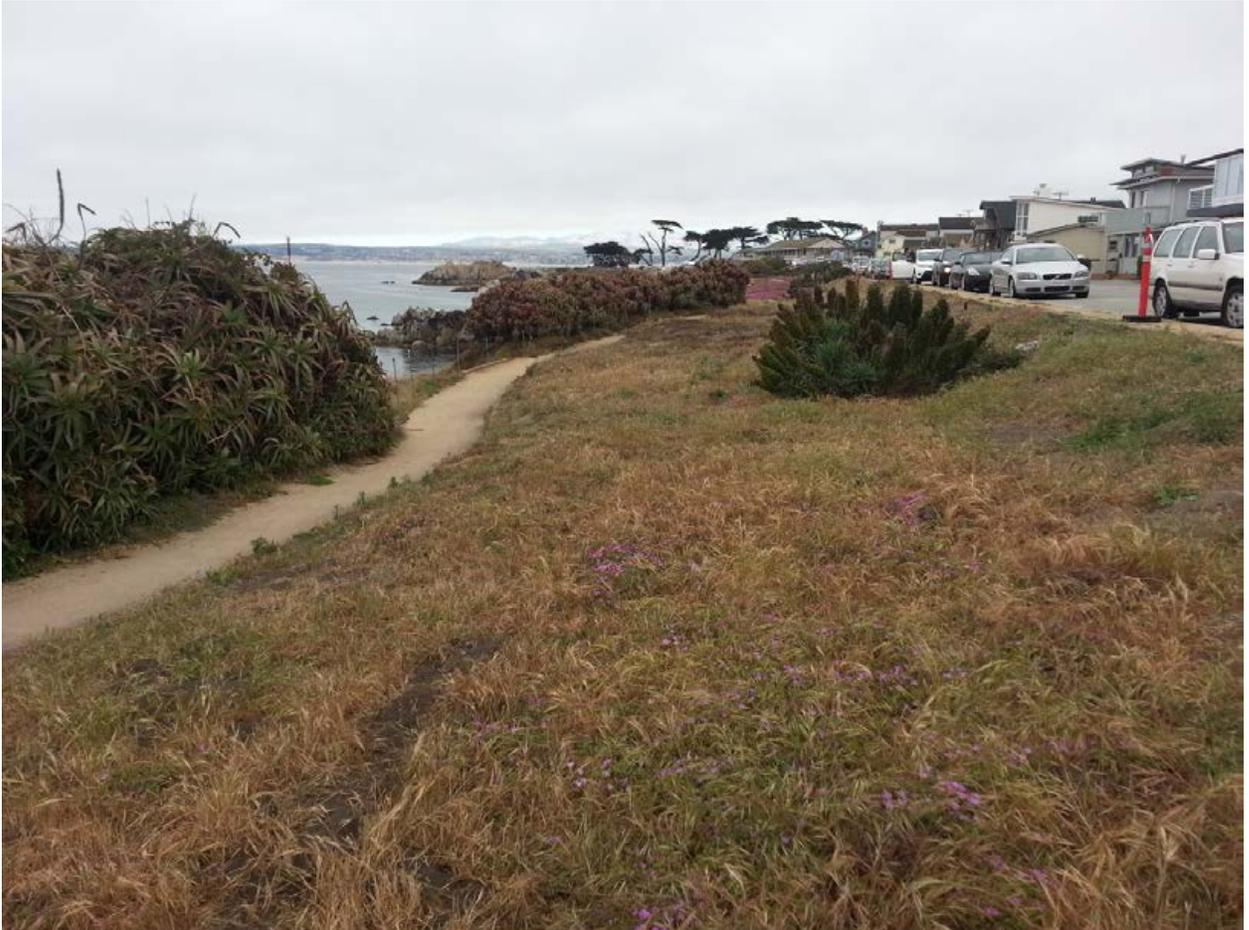
**Figure 34: Existing Trail and Ocean View Boulevard at Sea Palm East**

At Sea Palm East the Recreational Trail is presently in danger from erosion, however Ocean View Boulevard is not in danger. It appears feasible to realign the trail since the bluff edge is approximately 38 feet from the adjacent roadway and there is ample room to do so, as shown in Figure 34. This alternative is depicted in Appendix C on Sheets 11 and 12. Eventually, bluff recession will undermine the relocated trail, however relocation
