MEMORANDUM

From: Mark Foxx, CEG 1493 and John E. Kasunich, GE 455  
Haro Kasunich and Associates Inc.

Subject: Lovers Point Pier Damage

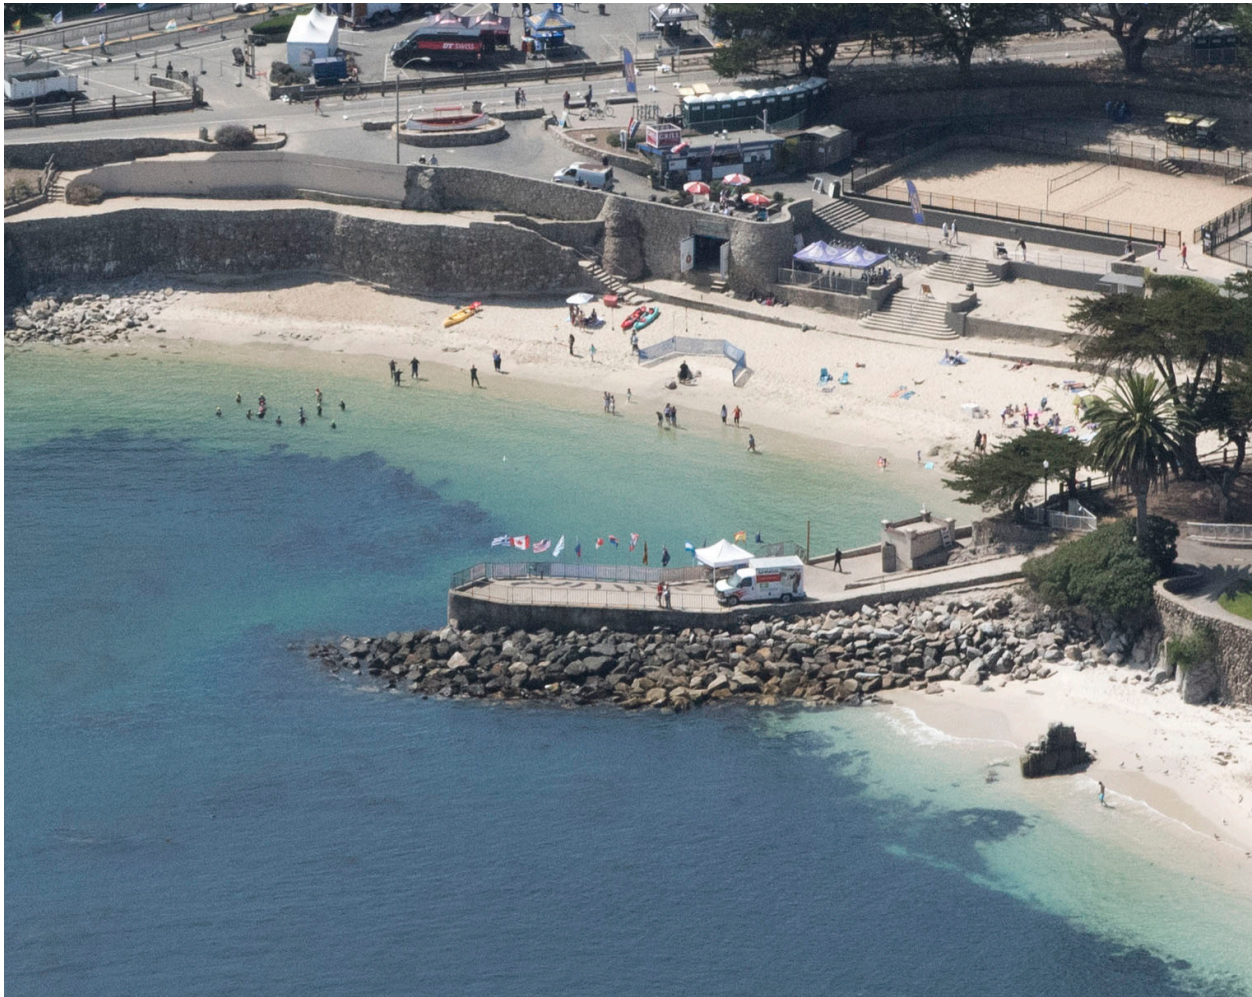
A photograph of the pier from September 2015, before the January 2020 damage occurred is shown below:
